ACCESSIBILITY AUDIT REPORT

MARINE DRIVE PROMENADE

NCPA TO MARINE DRIVE FLYOVER

DATE OF AUDIT: 22nd March 2021

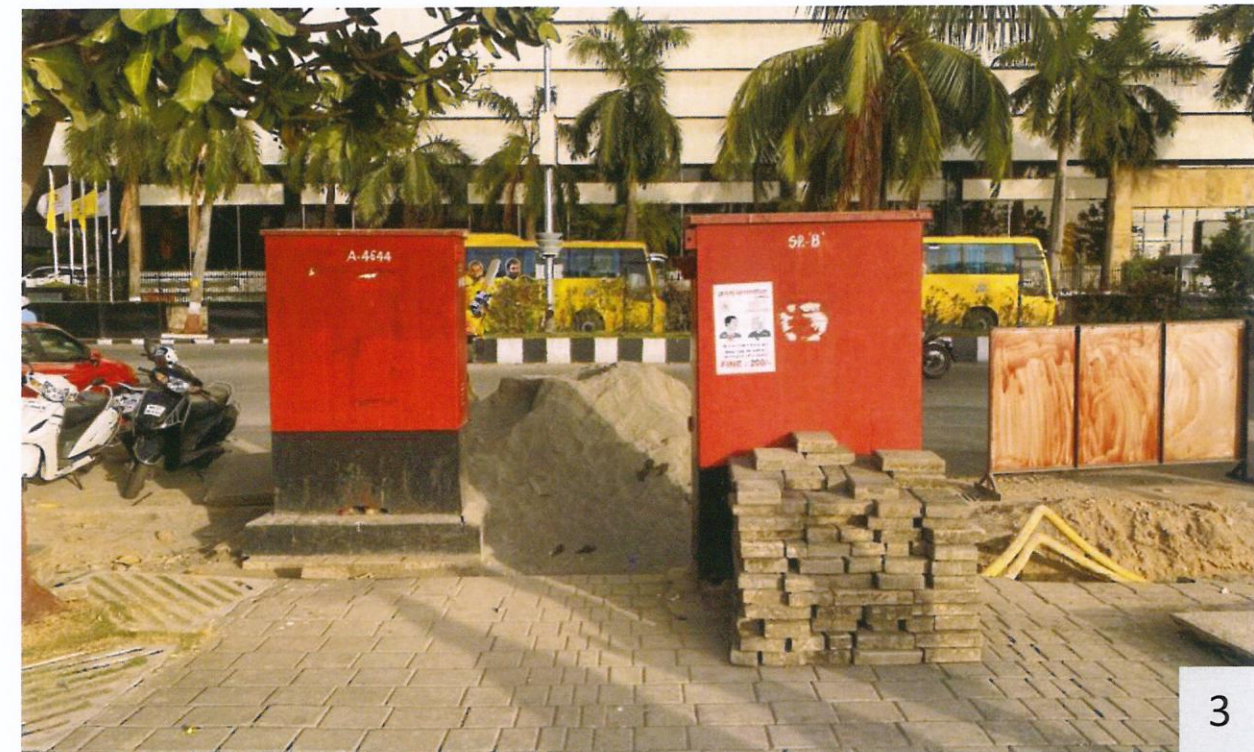
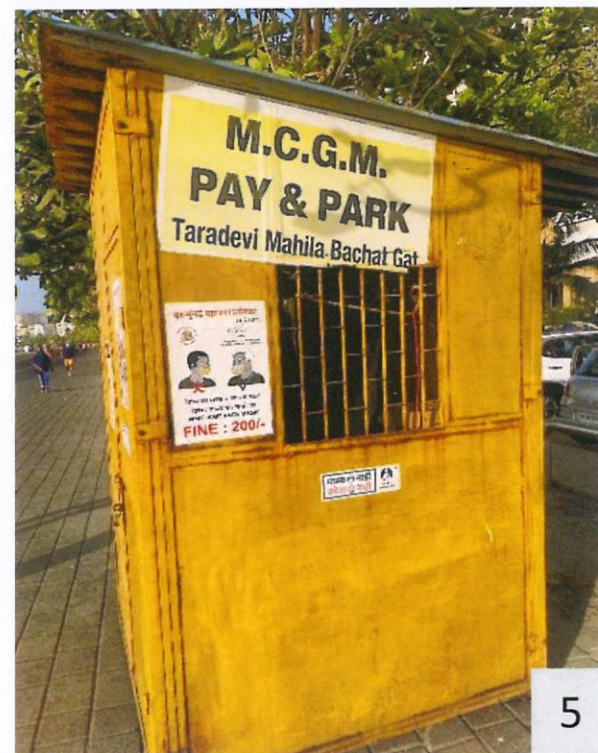
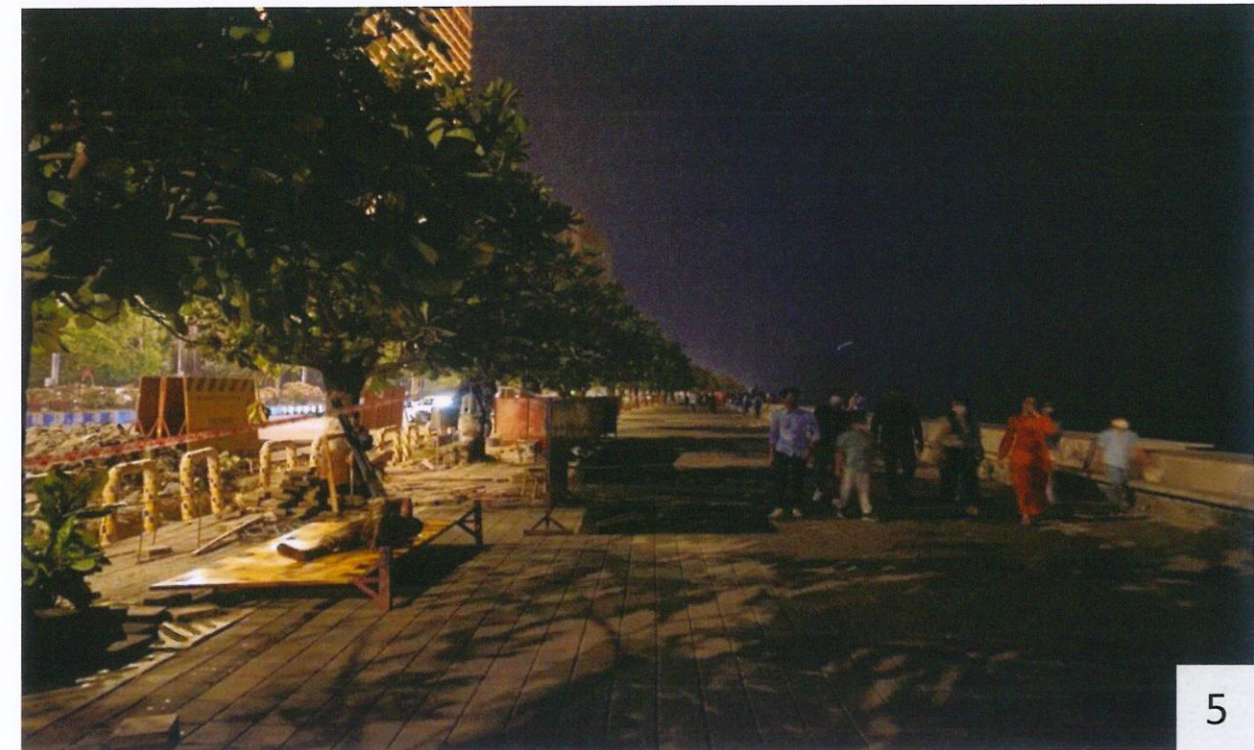
NCPA 200 to 300 M

Disability	No.	Question	Answers												Notes	Photograph no	Recommendation as per MoUD guidelines
NCPA		Interval/Serial No.	-50 to 0			0 to 100			100 - 200			200 - 300					
			Yes	No	NA	Yes	No	NA	Yes	No	NA	Yes	No	NA			
PROMENADE																	
L/VI	11.1	Is the pedestrian pathway /promenade is minimally 1800mm wide?														A1.1 , A3.3, A4.1,A5.2	
		Is the promenade is along the entire length of the road?														A1.2,A5.1	
L/VI		Is it less than 150mm high?													It's at a level of 200 mm to 300mm.	A1.5, C1.3, A3.6, A4.6	11.1- Sidewalks/ footpaths
L/VI		Are there no protruding objects or barriers on the promenade?													Intervals 0 to 100 and 200 to 300 do not have protuding objects.	A1.3, A1.4, A3.1, A3.2, A4.3, A4.5, A5.3, A5.4, A5.5	11.1- Sidewalks/ footpaths
L/VI		Are the protruding objects guarded?													No guards provided.	B1.3	11.1- Sidewalks/ footpaths 5.1.4- Barriers and Hazards

Is the pathway levelled?													Undulating at some points because of broken paving and unusual slopes.	A1.4, A3.1, A3.2, A4.3, A4.4, A1.6	11.1- Sidewalks/ footpaths
L		Is there 1500 mm x 1500mm space to allow a wheelchair user to turn around at some point on the pathway?														A1.2, A3.3, A4.2	
L/VI		Is the finish non-slip and non-reflective?															
VI		Is the pathway well illuminated at night?													Since there are no lights on the promenade itself, the illumination is by the street lights on the median. Most of this light is obstructed by the tree foliage.	A5.5	11.1- Sidewalks/ footpaths 5.1.8- Lighting and Walkways

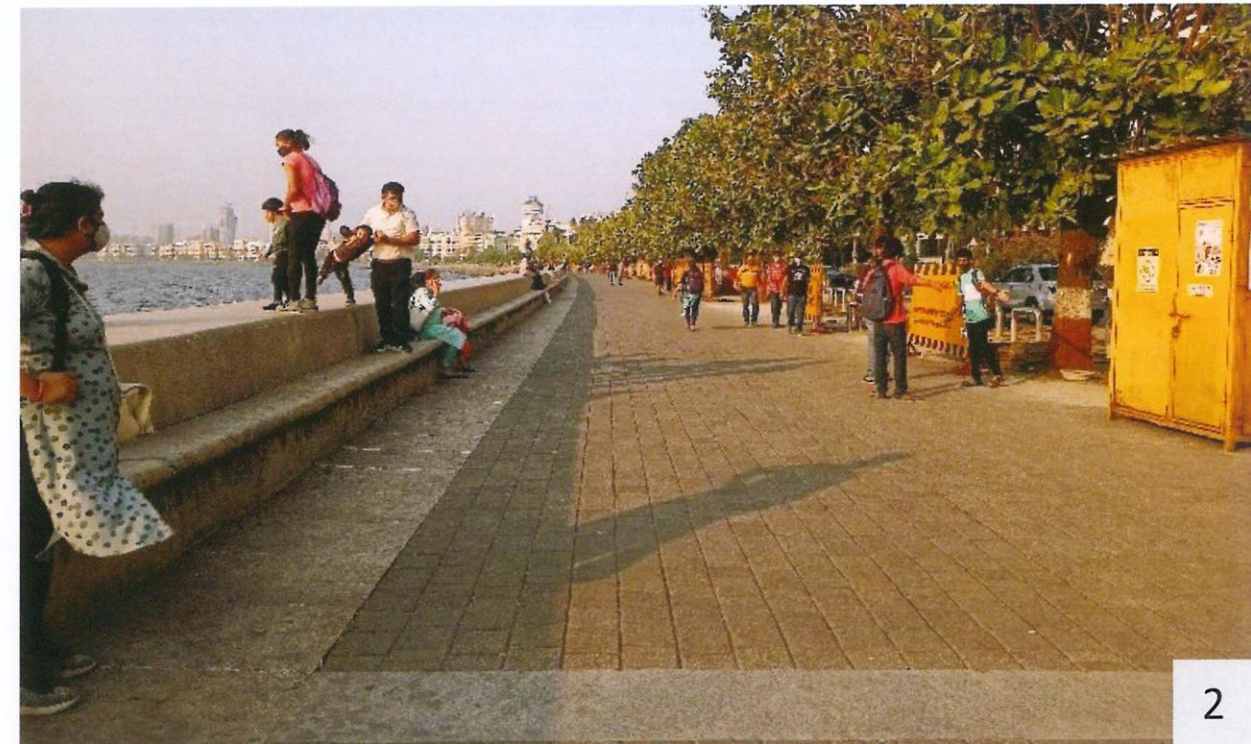
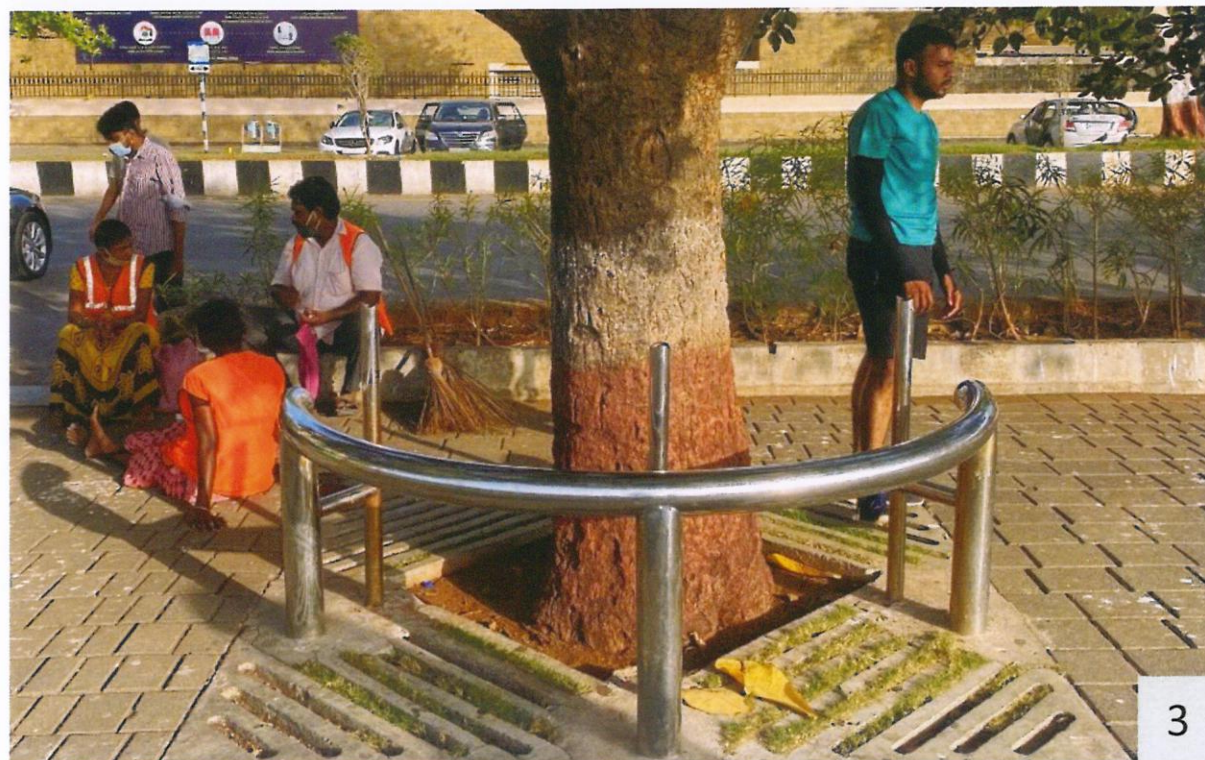
Disability	No.	Question	Answers												Notes	Photograph no	Recommendation as per MoUD guidelines
NCPA		Interval/Serial No.	-50 to 0			0 to 100			100 - 200			200 - 300					
			Yes	No	NA	Yes	No	NA	Yes	No	NA	Yes	No	NA			
		Are the trees on the promenade guarded?		No			No			No			No			A1.4	11.1- Sidewalks/ footpaths
		Are there dustbins on the promenade?	Yes			Yes			Yes			Yes					
		Are the dustbins accessible- at a height between 900-1000mm?		No			No			No			No		They are at the height of 1200mm.	D1.2	3.2- Reach Range
		Are the Inspection chambers well flushed with the footpath?			NA			NA			NA			NA			
L/VI		Are the pathways maintained and kept free of unwanted barriers such as furniture, planters, etc?		No			No			No		Yes			At the time of the audit, bricks, pipes and debris were stacked at certain spots on the promenade. Although this stacking of construction materials is temporary, care must be taken that they are placed such that all the access points and utilities are free of such barriers.	A1.3, A3.5, A4.5, A5.3

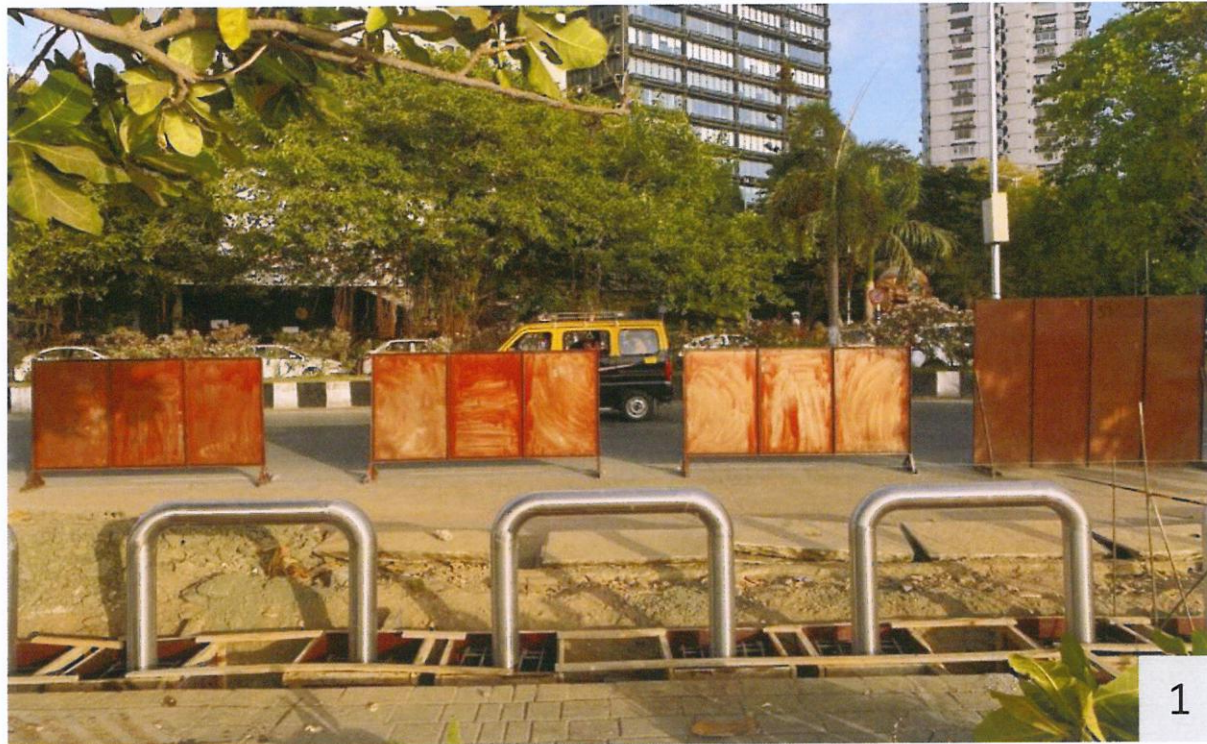
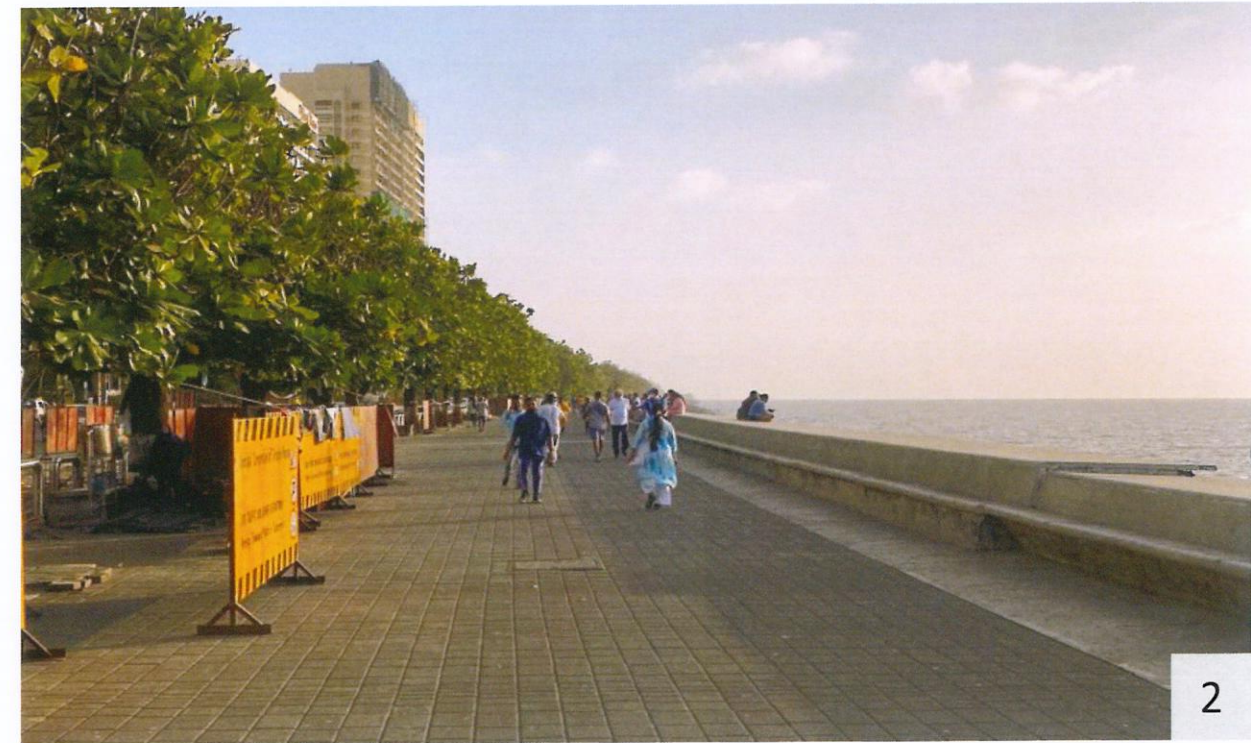
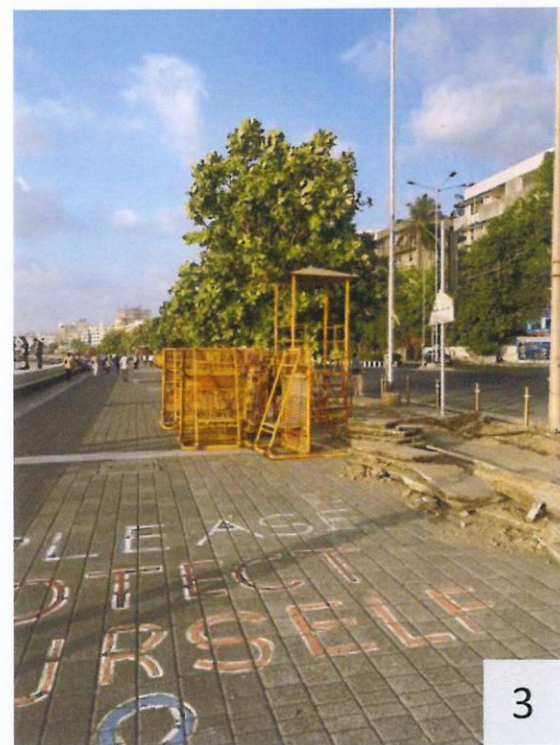
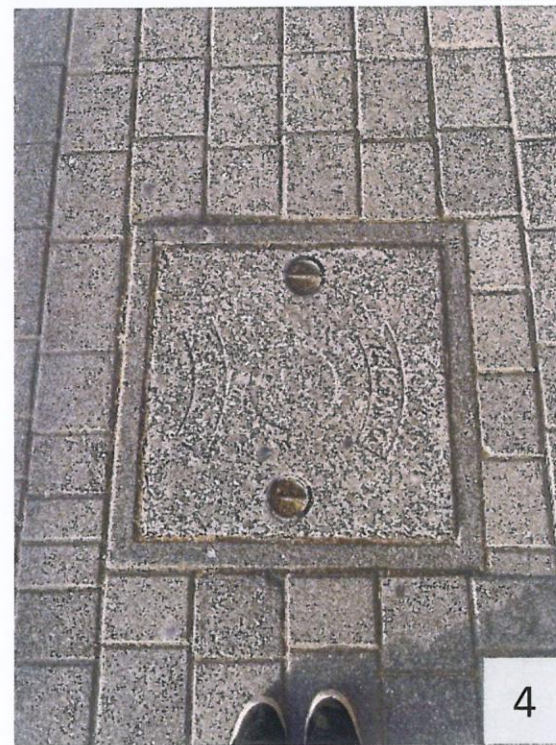
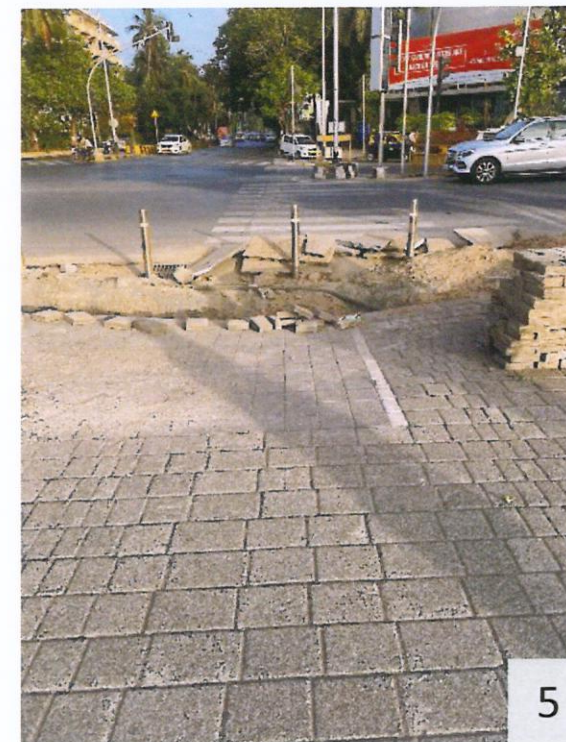
NCPA 400 to 500 M

Disability	No.	Question	Answers						Notes	Photograph no	Recommendation as per MoUD guidelines
NCPA		Interval/Serial No.	300-400			400- MD 000					
			Yes	No	NA	Yes	No	NA			
PROMENADE											
L/VI	11.1	Is the pedestrian pathway /promenade is minimally 1800mm wide?								E1.1, E1.2, E2.2	
		Is the promenade is along the entire length of the road?									
L/VI		Is it less than 150mm high?							Its at a level of 200 mm to 300mm.		11.1- Sidewalks/ footpaths
L/VI		Are there protruding objects or barriers on the pathway?							Intervals 400 to 0 (MD) do not have protuding objects. There is a temporary structure on the stretch 300-400M which acts as a barrier.	E1.4	11.1- Sidewalks/ footpaths
L/VI		Are the protruding objects guarded?							No guards provided.		11.1- Sidewalks/ footpaths 5.1.4- Barriers and Hazards
		Is the pathway levelled?							Undulating at some points because of broken paving.	E1.1, E1.2, E2.3	11.1- Sidewalks/ footpaths

L		Is there 1500 mm x 1500mm space to allow a wheelchair user to turn around at some point on the pathway?									
L/VI		Is the finish non-slip and non-reflective?									
VI		Is the pathway well illuminated at night?							Since there are no lights on the promenade itself, the illumination is by the street lights on the median. Most of this light is obstructed by the tree foliage.		11.1- Sidewalks/ footpaths 5.1.8- Lighting and Walkways

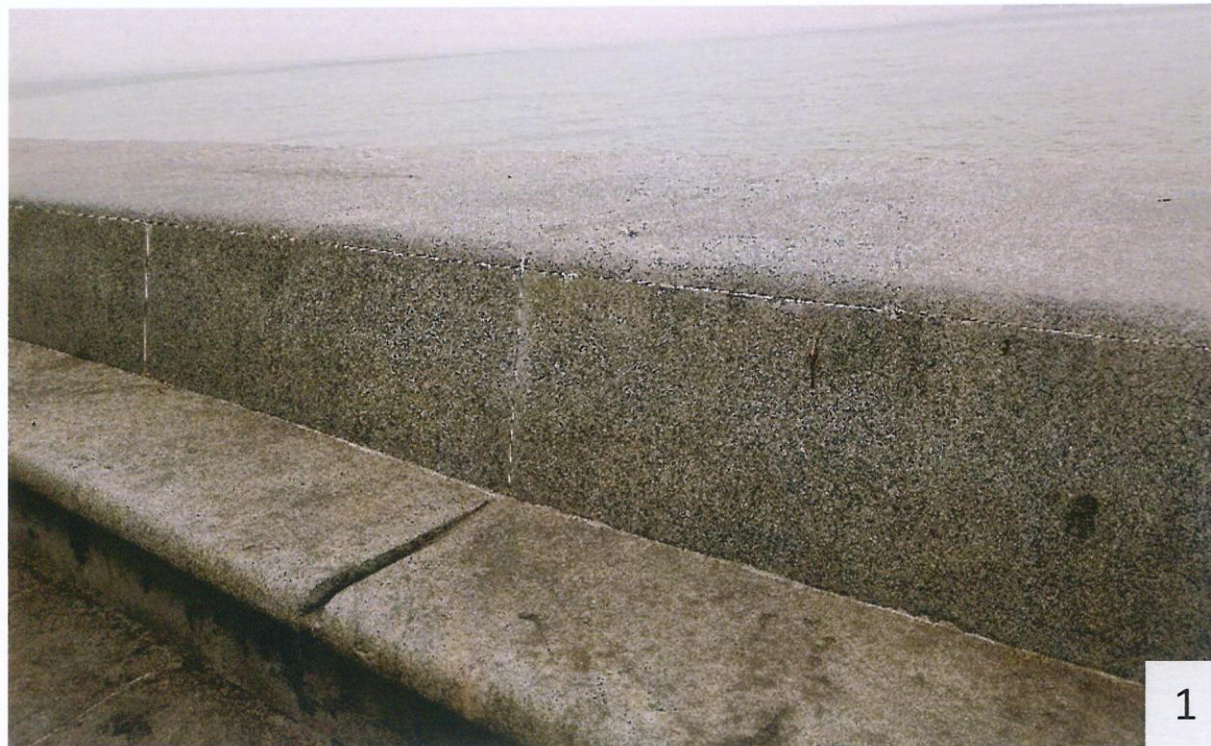
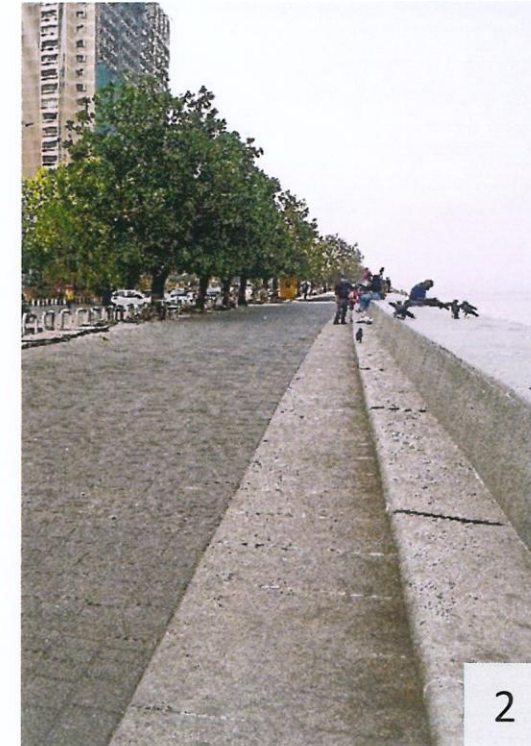
Disability	No.	Question	Answers						Notes	Photograph no	Recommendation as per MoUD guidelines
NCPA		Interval/Serial No.	300-400			400- MD 000					
			Yes	No	NA	Yes	No	NA			
		Are the trees on the promenade guarded?									11.1- Sidewalks/ footpaths
		Are there dustbins on the promenade?								H1.3	
		Are the dustbins accessible- at a height between 900-1000mm?							They are at the height of 1200mm.	H1.3	3.2- Reach Range
		Are the Inspection chambers well flushed with the footpath?							No inspection chambers present in 300 to 400m interval of the promenade.	E2.4	
L/VI		Are the pathways maintained and kept free of unwanted barriers such as furniture, planters, etc?								E1.5, E1.4	11.1- Sidewalks/ footpaths

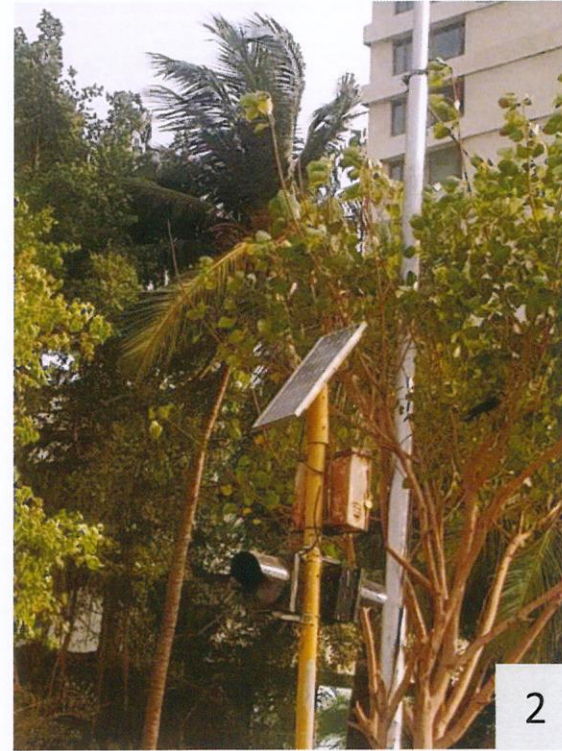
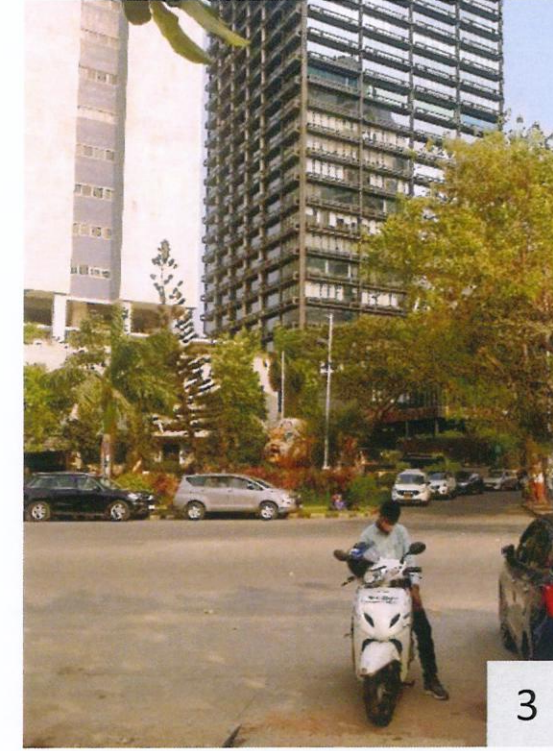
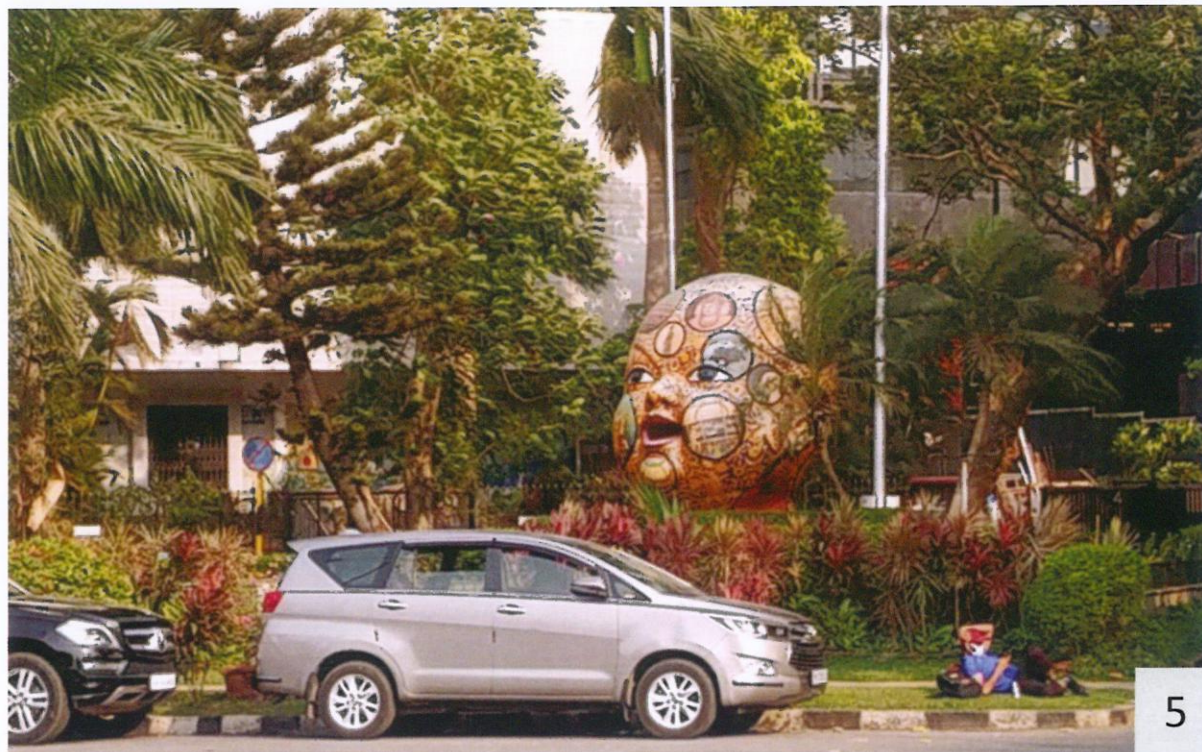
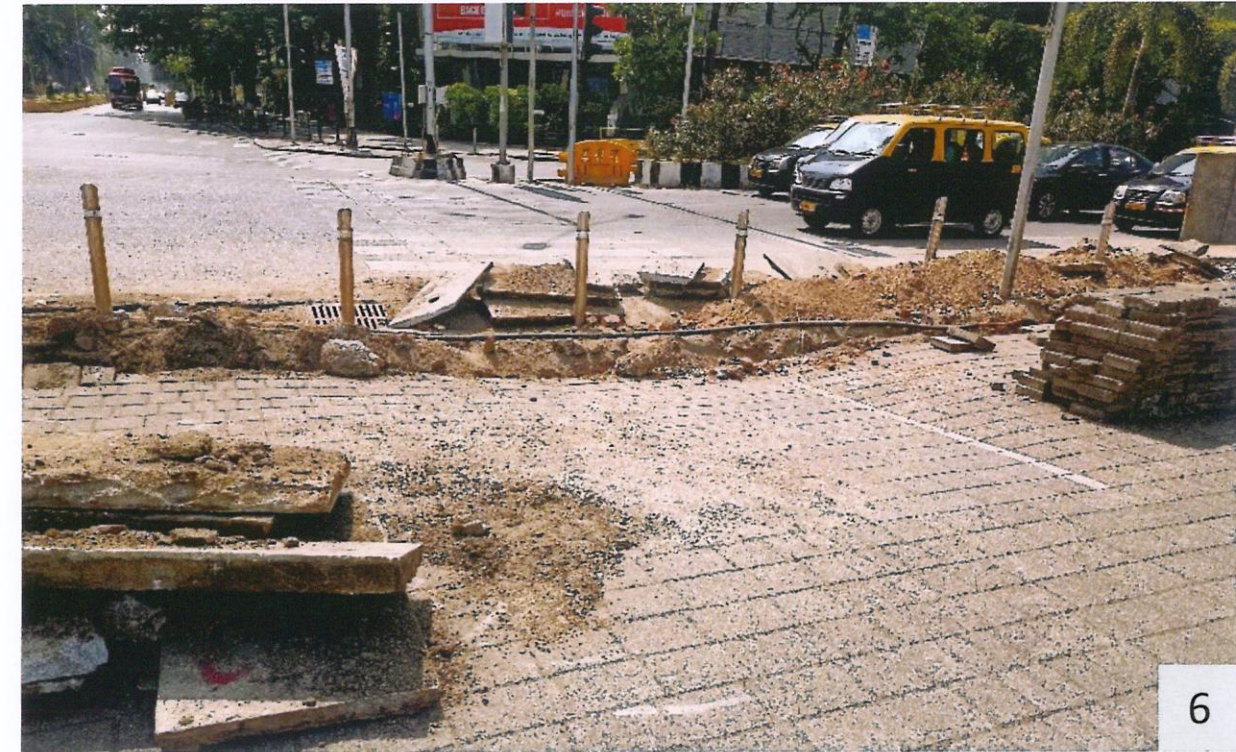
Disability	No.	Question	Answers						Notes	Photograph no	Recommendation as per MoUD guidelines
NCPA		Interval /Serial No.	300-400			400- MD 000					
			Yes	No	NA	Yes	No	NA			
INTERSECTIONS											
L/VI		Is the footpath at the intersection 1800mm wide?								G1.6	
		Is a median is present?								G1.1	11.4- Medians and Refuge Islands
L/VI		Is the median an area at ground level? Can it be used as refuge area during crossing?							Intersection is present but No zebra crossing is provided.		
L/VI		Are the signals easily readable and are they placed such that they can be seen while crossing?							The traffic lights are placed such that they aren't easily identifiable. The orientation of these traffic lights meant for pedestrians are inefficient.	G1.2	11.5- Traffic Signals
VI		Is there an audible alert when the signal goes on and off?							No audible alert.		11.5- Traffic Signals
		Is there an interval indicating device on the traffic signal?							No time interval indicating device present.		11.5- Traffic Signals

Is the time interval allowed for crossing programmed according to the slowest crossing persons?							It was observed that at most of the crossings had a very short interval which will not allow a person to cross at a comfortable pace.		11.5- Traffic Signals

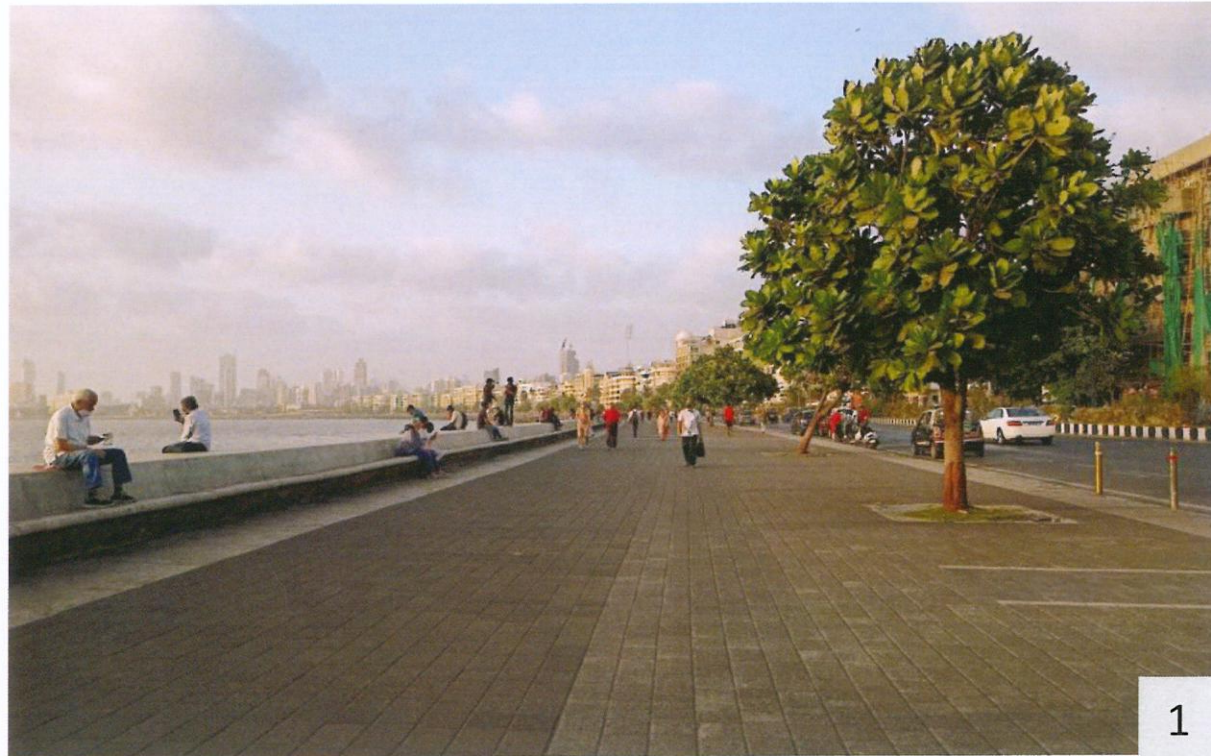
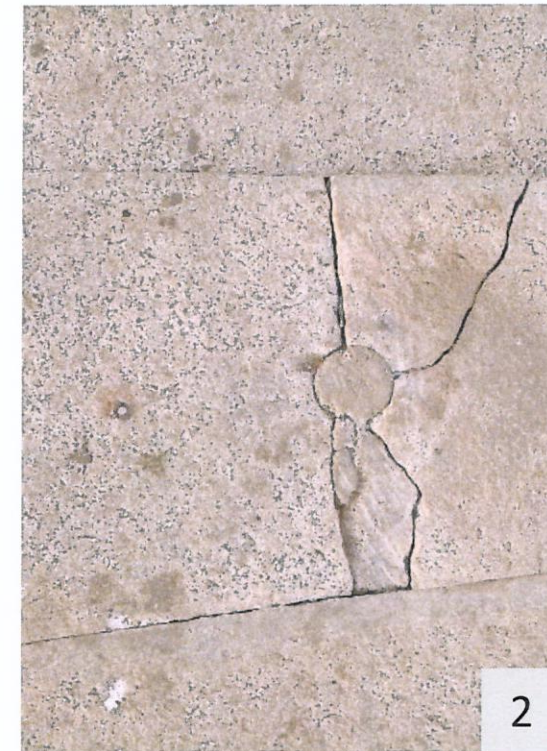
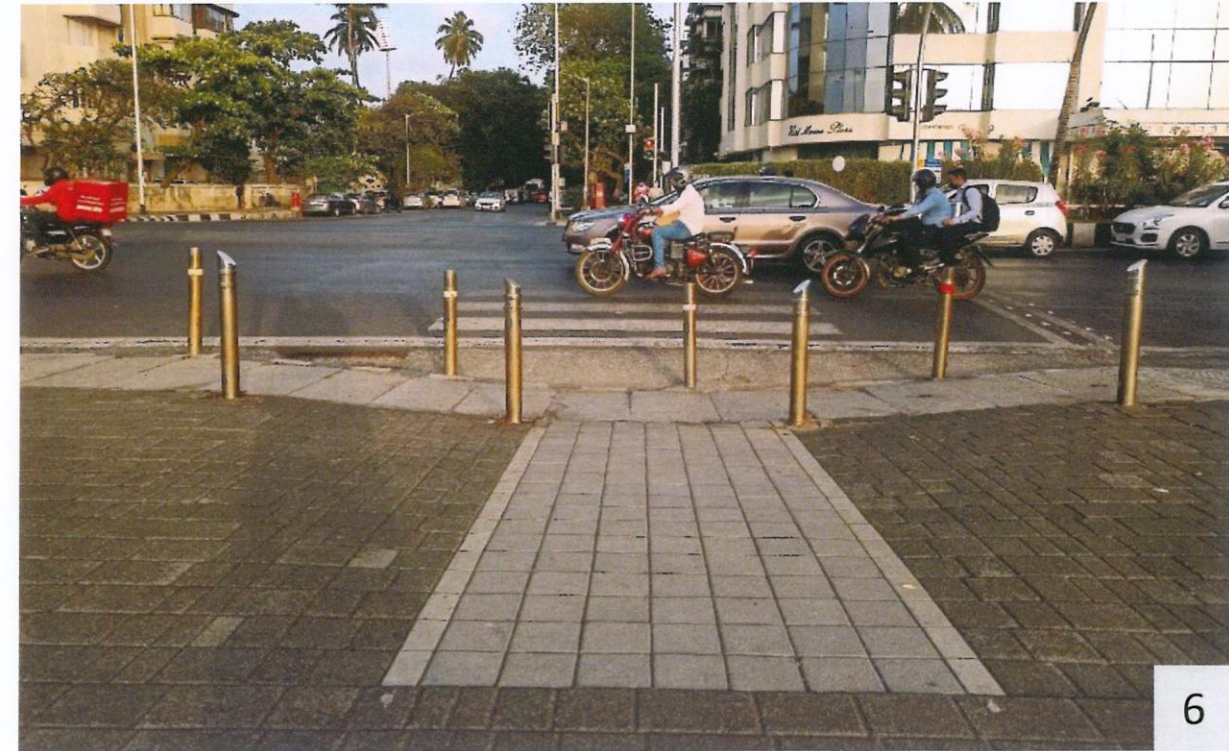
MD 200 to 300 M

LAYOUT PLAN INDICATING BARRIERS

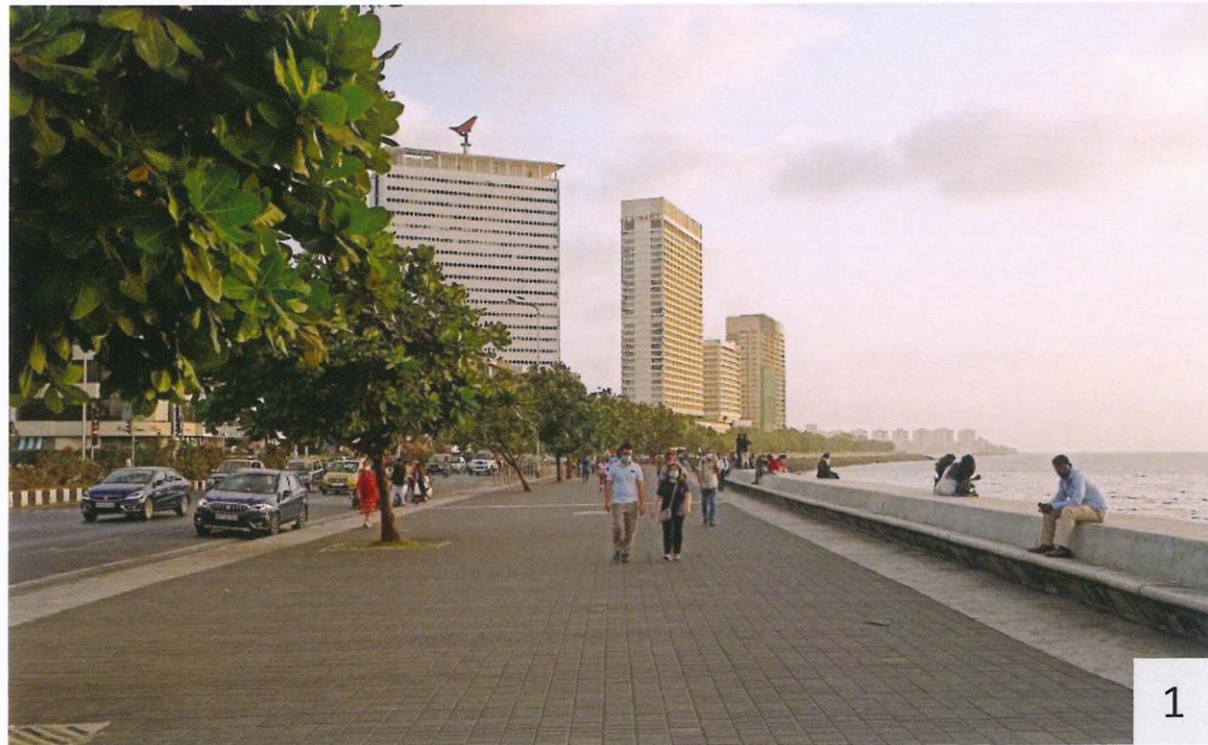
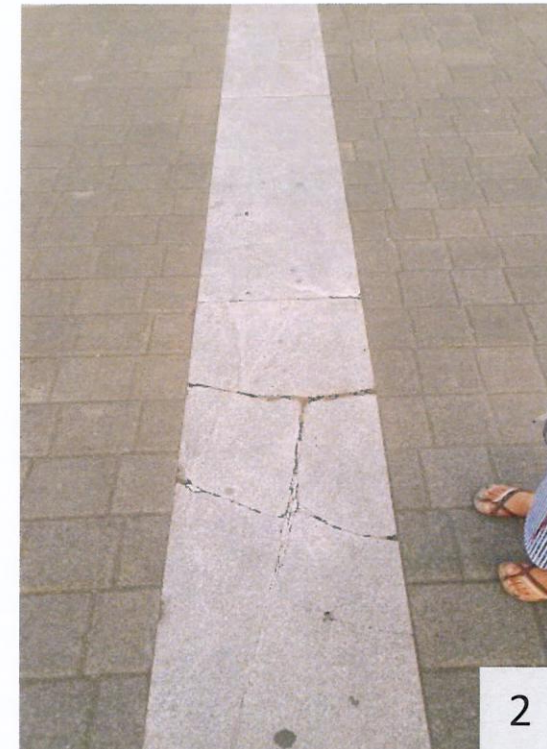
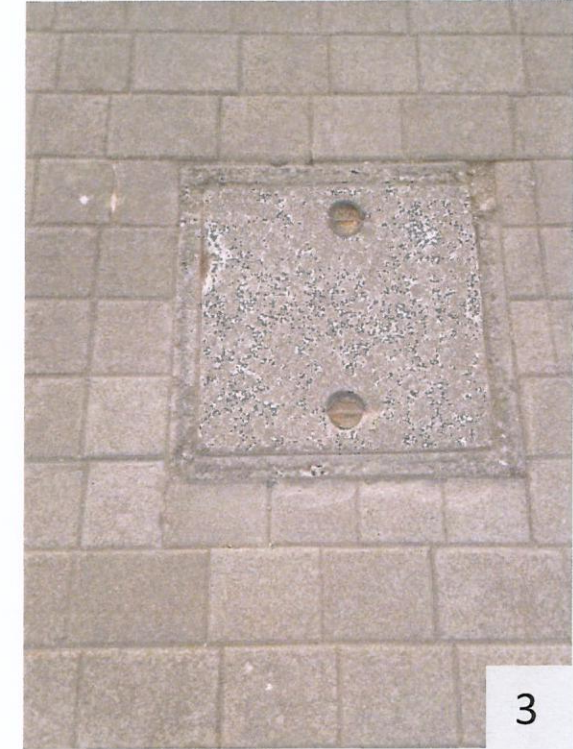
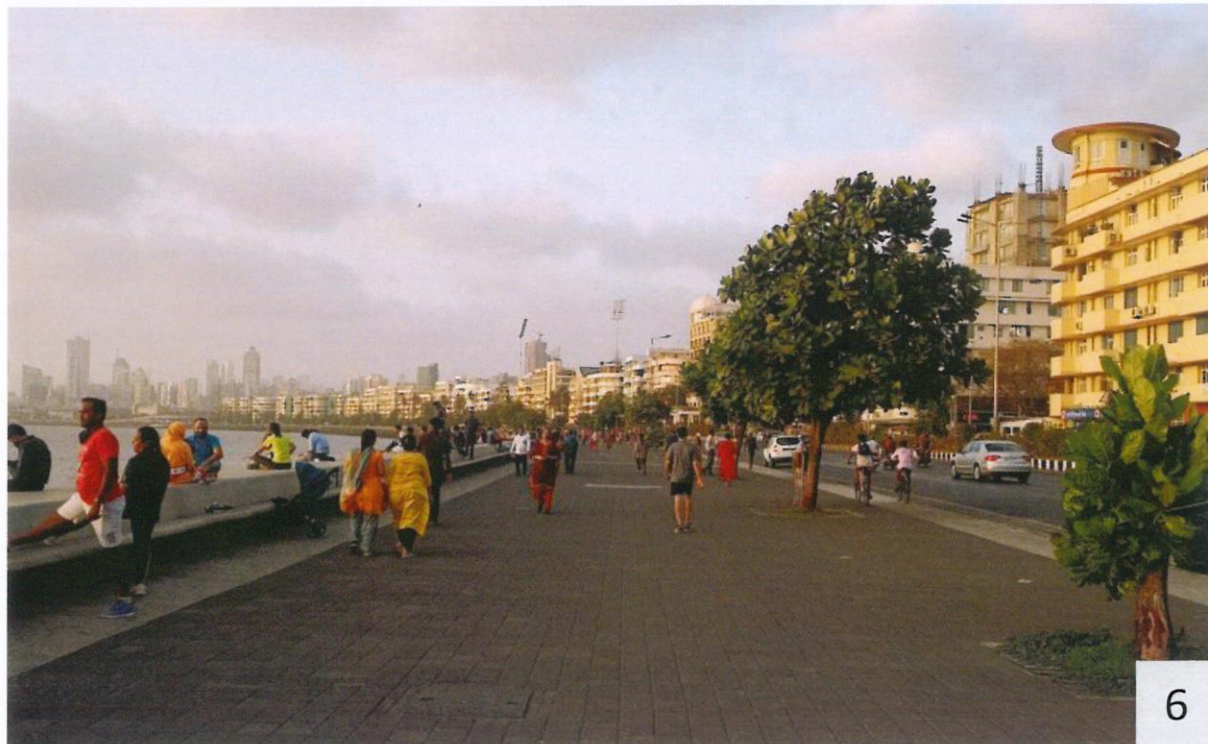
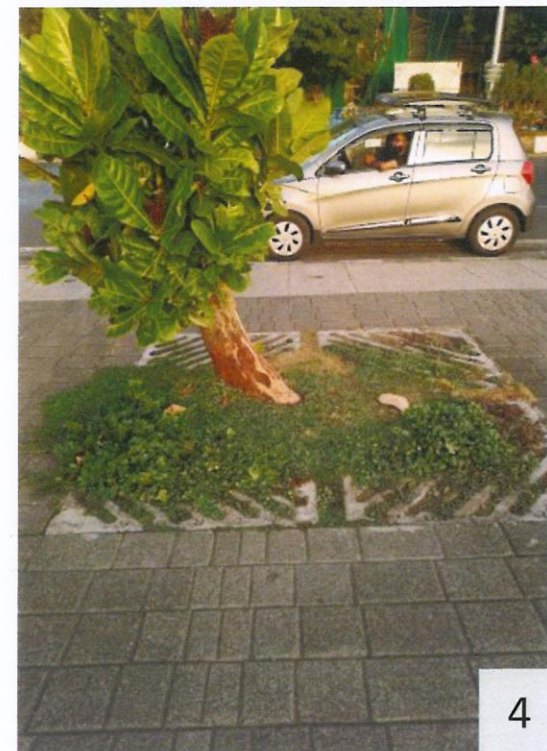
MD 300 to 400 M

LAYOUT PLAN INDICATING BARRIERS

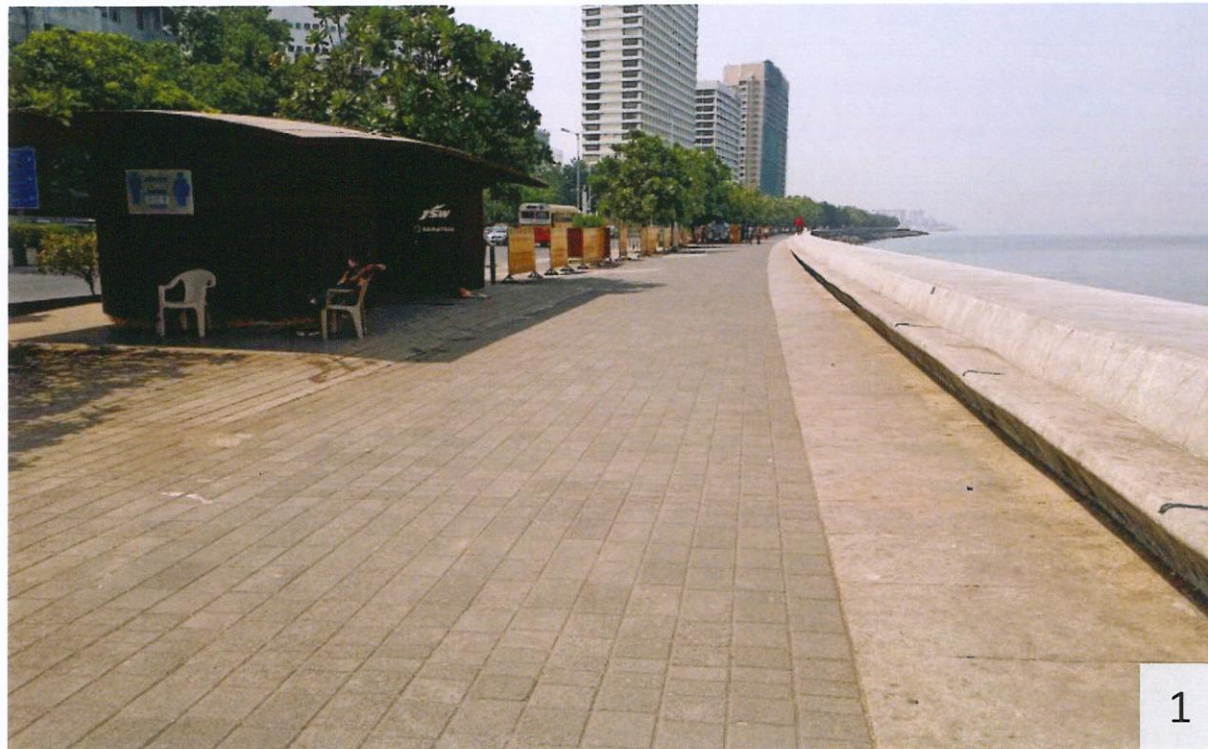
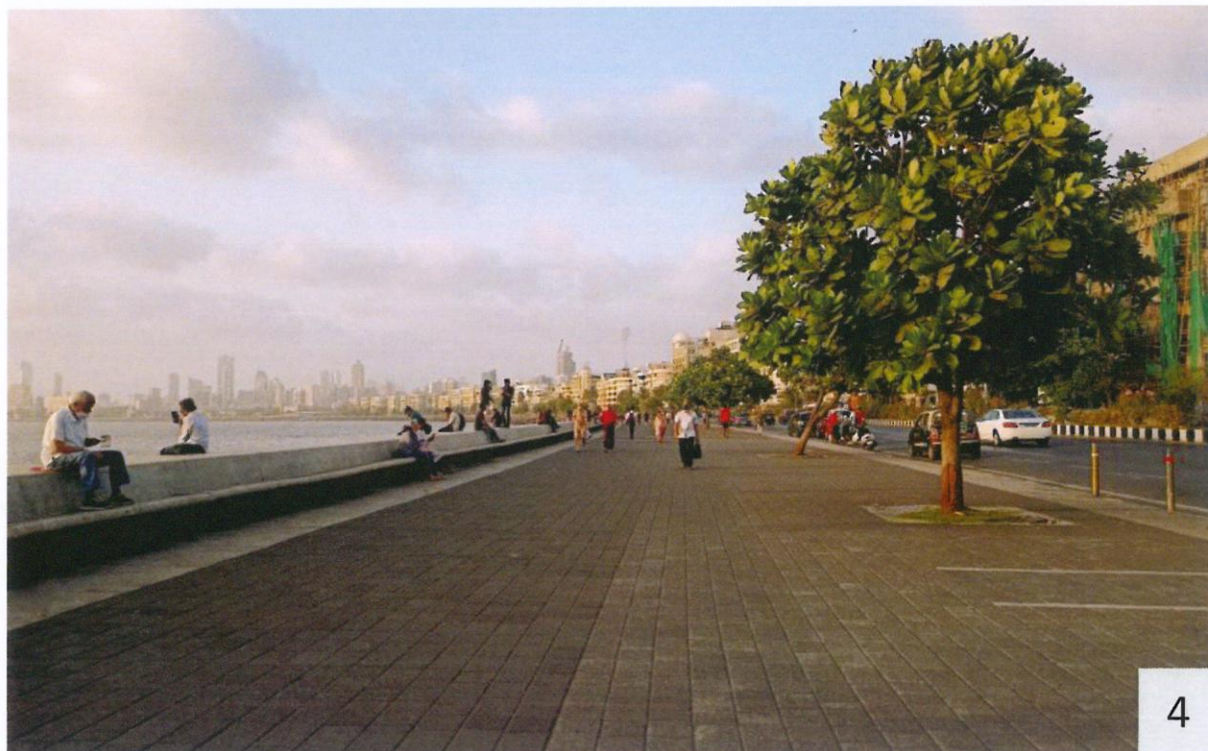
Disability	No.	Question	Answers												Notes	Photograph no	Recommendation as per MoU guidelines
Marine Drive		Interval/Serial No.	0-100			100-200			200-300			300-400					
			Yes	No	NA	Yes	No	NA	Yes	No	NA	Yes	No	NA			
L/VI		Are the pathways maintained and kept free of unwanted barriers such as furniture, planters, etc?													At the time of the audit, bricks, pipes and debris were stacked at certain spots on the promenade. Although this stacking of construction materials is temporary, care must be taken that they are placed such that all the access points and utilities are free of such barriers. The promenade has not been designed to include police barricades. These are however seen as a present day necessity the result being that they cause an obstacle.	I1.6, I1.7	11.1- Sidewalks/ footpaths

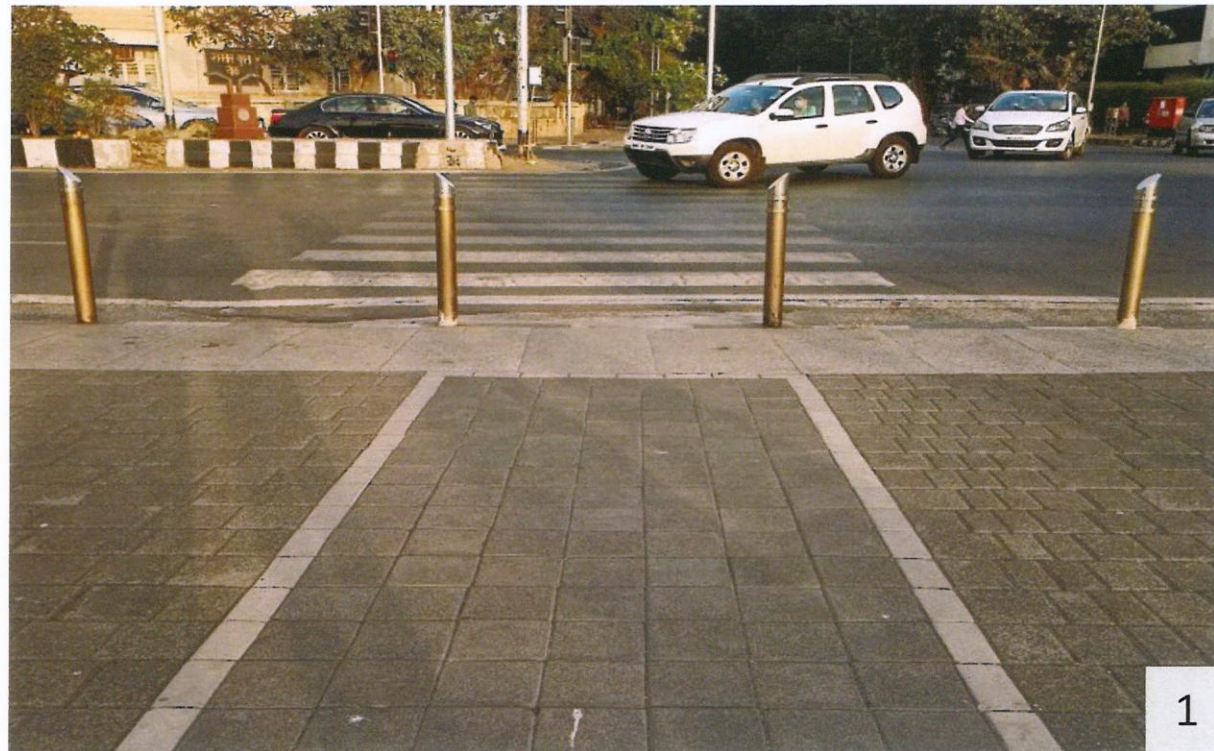
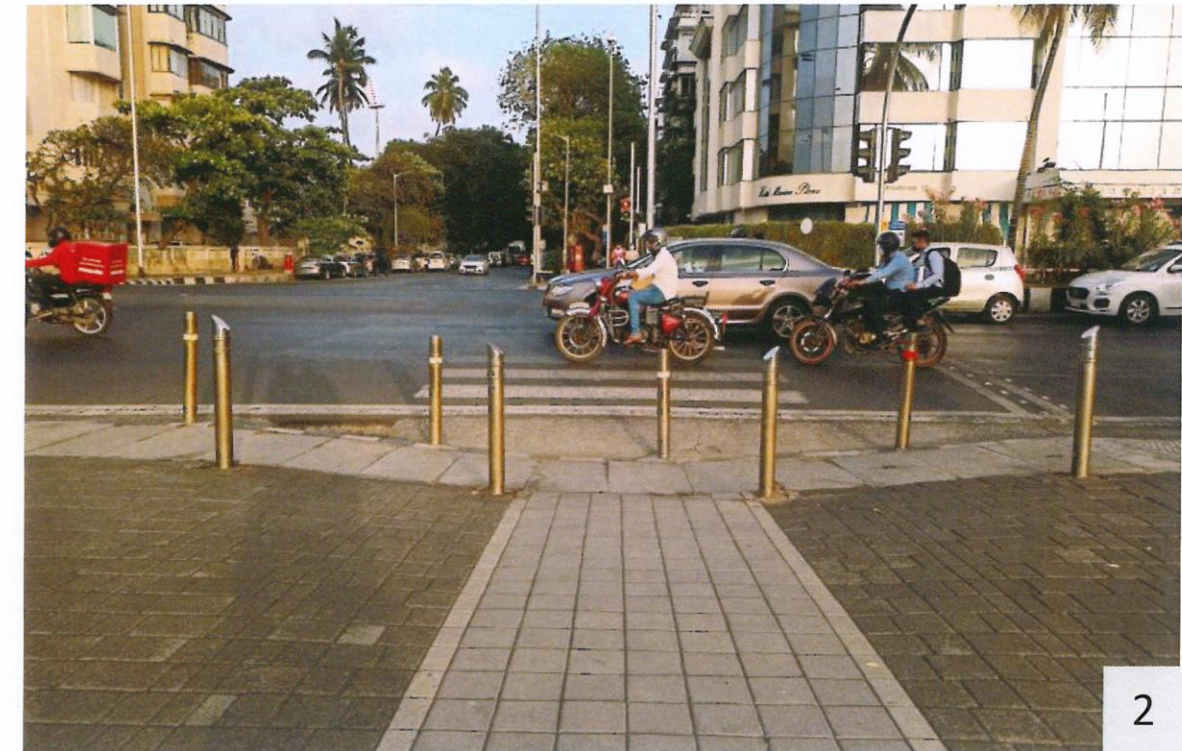
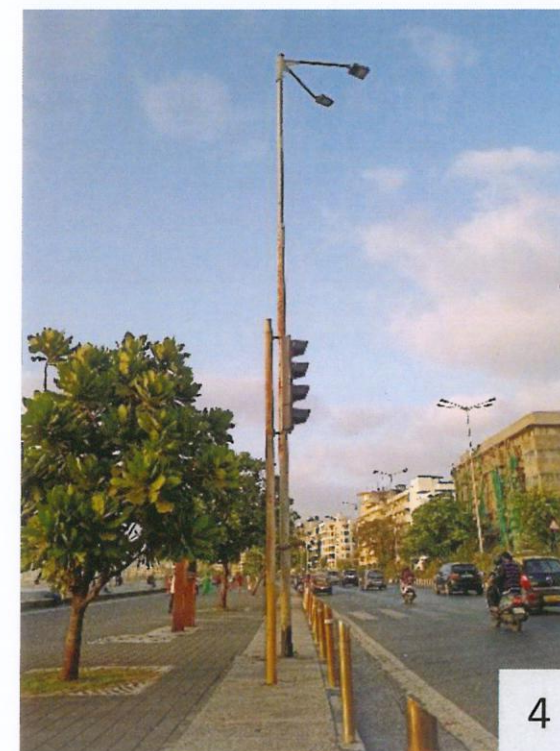
Disability	No.	Question	Answers												Notes	Photograph no	Recommendation as per MoUD guidelines
Marine Drive		Interval /Serial No.	0-100			100-200			200-300			300-400					
			Yes	No	NA	Yes	No	NA	Yes	No	NA	Yes	No	NA			
RESTING SPACES																	
L/VI		Where there are large spaces, are resting facilities provided at 30 meters of intervals?														J1.1	
		Is there an adjoining space for a wheelchair next to benches and public seats?													Seating is continuous- the promenade seating abutting the shore.	J1.1	
L/VI		Are public seats with height of 450-480mm?													Only the lower seating. The seating (katta) abutting the sea is higher and not accessible.	J1.1, J1.2, J1.3	
L/VI		Are knee spaces at accessible tables with a height of 750mm and knee space of 750mm wide and 480mm deep?													No tables on the promenade
