ACCESSIBILITY AUDIT REPORT

MARINE DRIVE PROMENADE

NCPA TO MARINE DRIVE FLYOVER

DATE OF AUDIT: 22nd March 2021

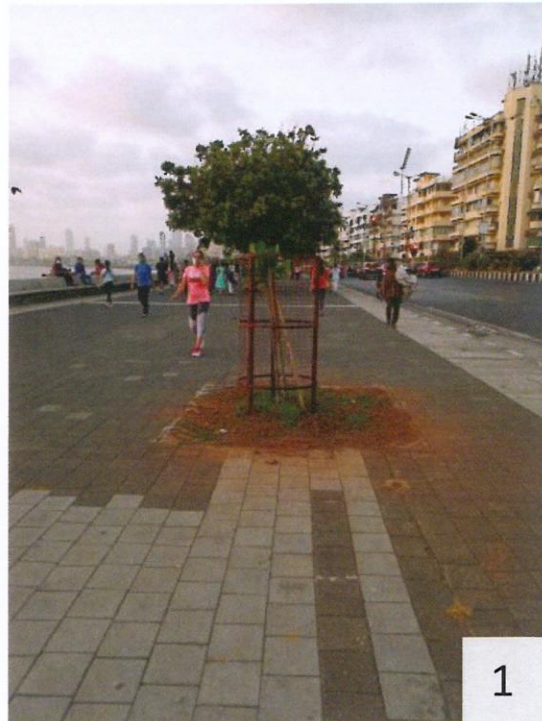
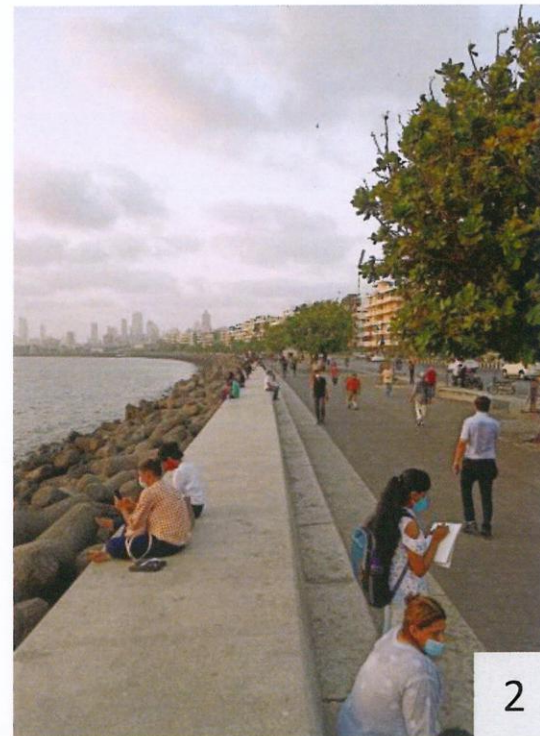
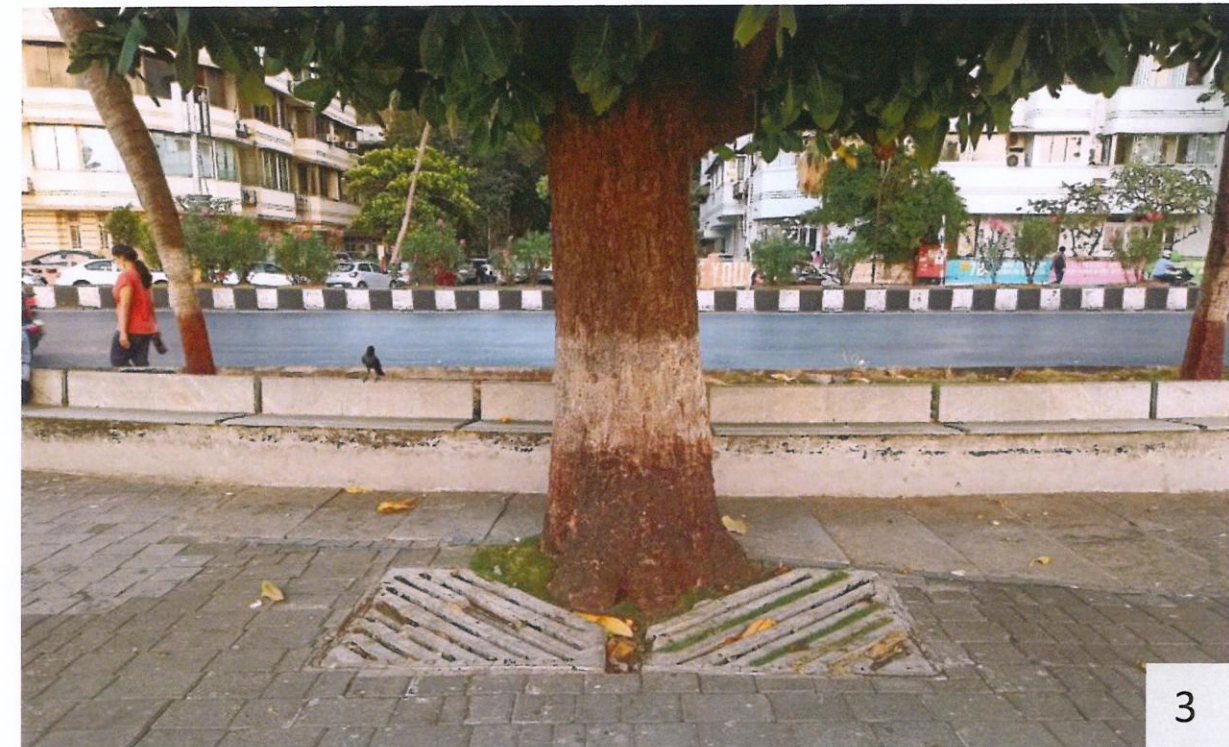
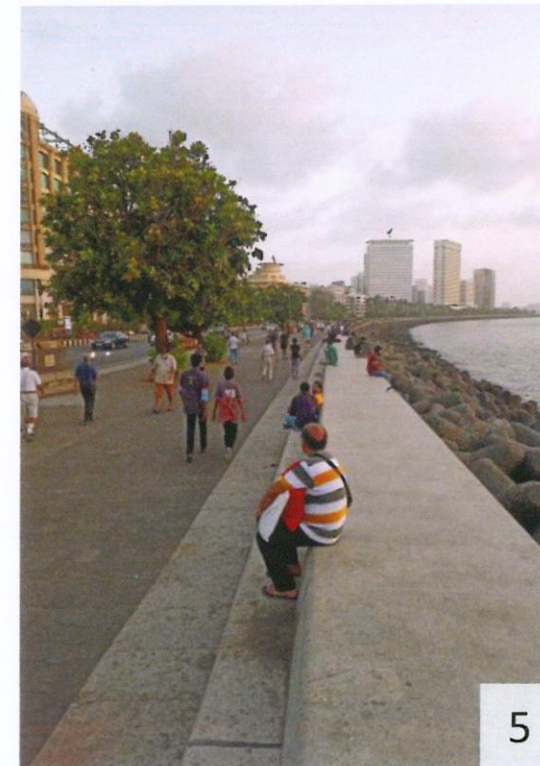
MD 700 M to 800 M
Chateau Marine, B Road to Ganga Vihar

Disability	No.	Question	Answers												Notes	Photograph no	Recommendation as per MoUD guidelines
Marine Drive		Interval/Serial No.	400-500			500-600			600-700			700-800					
			Yes	No	NA	Yes	No	NA	Yes	No	NA	Yes	No	NA			
PROMENADE																	
L/VI	11.1	Is the pedestrian pathway /promenade is minimally 1800mm wide?													M1.7, M1.4, M2.1, M2.2, M3.4, M3.6, M4.2, M4.4		
		Is the promenade is along the entire length of the road?															
L/VI		Is it less than 150mm high?													Its at a level of 200 mm to 300mm.	11.1- Sidewalks/ footpaths	
L/VI		Are there protruding objects or barriers on the pathway?													Interval 400 to 500 do not have protuding objects.	M1.1, M1.2, M1.6, 11.1- Sidewalks/ footpaths	
L/VI		Are the protruding objects guarded?													No guards provided.	M1.7 11.1- Sidewalks/ footpaths 5.1.4- Barriers and Hazards	
		Is the pathway levelled?													Undulating at some points because of broken paving.	M1.2, M1.6, M2.3, M3.3, M4.1, M4.3 11.1- Sidewalks/ footpaths

L		Is there 1500 mm x 1500mm space to allow a wheelchair user to turn around at some point on the pathway?													M1.7, M2.1, M3.6, M4.4		
L/VI		Is the finish non-slip and non-reflective?													M1.7, M2.1, M3.6, M4.4		
VI		Is the pathway well illuminated at night?													Although this stretch is fairly illuminated at night as compared to rest of Marine Drive, it may be difficult for a person with partial vision to navigate this stretch.	11.1- Sidewalks/ footpaths 5.1.8- Lighting and Walkways

L/VI		Does the footpath have kerb cuts for persons to get on and get off the pathway?															11.2- Kerb Ramps at walkways and pedestrian crossing
VI		Have tactile warning blocks been installed next to all entry and exit points from the pathway													No tactile markings are provided.		11.1- Sidewalks/ footpaths
		Are the trees on the promenade guarded?														M1.7, M2.6, M3.6, M4.3	11.1- Sidewalks/ footpaths
		Are there dustbins on the promenade?														P1.1	
		Are the dustbins accessible- at a height between 900-1000mm?													They are at the height of 1200mm.	P1.1	3.2- Reach Range
		Are the Inspection chambers well flushed with the footpath?													No inspection chambers present in 400 to 500 interval of the promenade.	M1.2, M2.4,OI

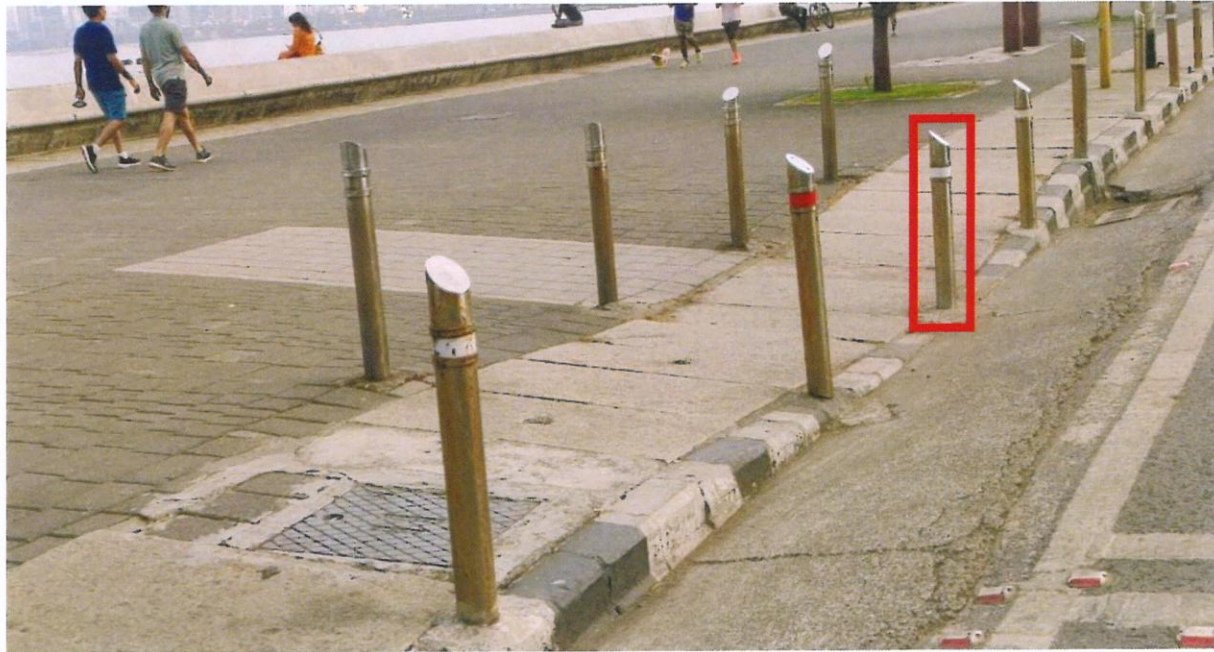
1. Ramps and access ways to and from the promenade

Kerb ramp present at the intersection has an efficient gradient but the road is at a higher level than the point at which the ramp starts. This makes a valley between the road and the promenade with a steeper slope from the end of ramp to the road making it difficult to negotiate.

The bollards placed at the center of the access way is the path of the wheelchair access.

1. Promenade: The access points to and from the promenade are not executed efficiently. As noted in the general observations, although the ramps are of sufficient gradient at certain points, the road is at a higher level therefore the slope between the promenade edge and the road level is steep and cannot be negotiated by persons using wheelchair.

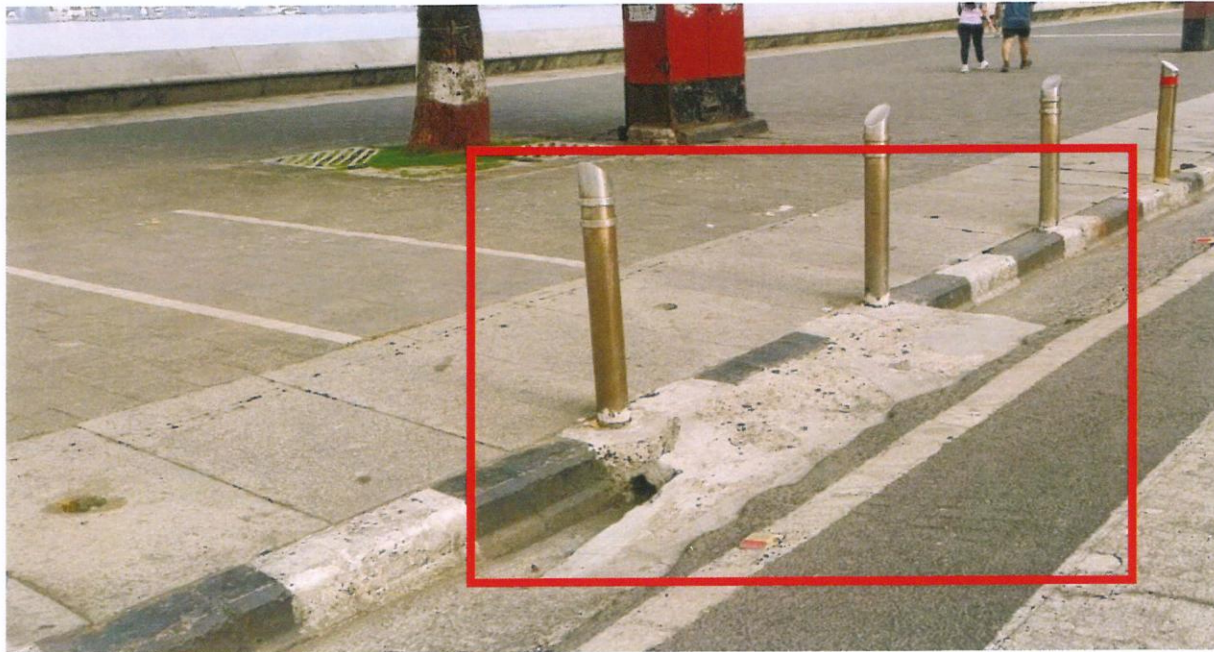
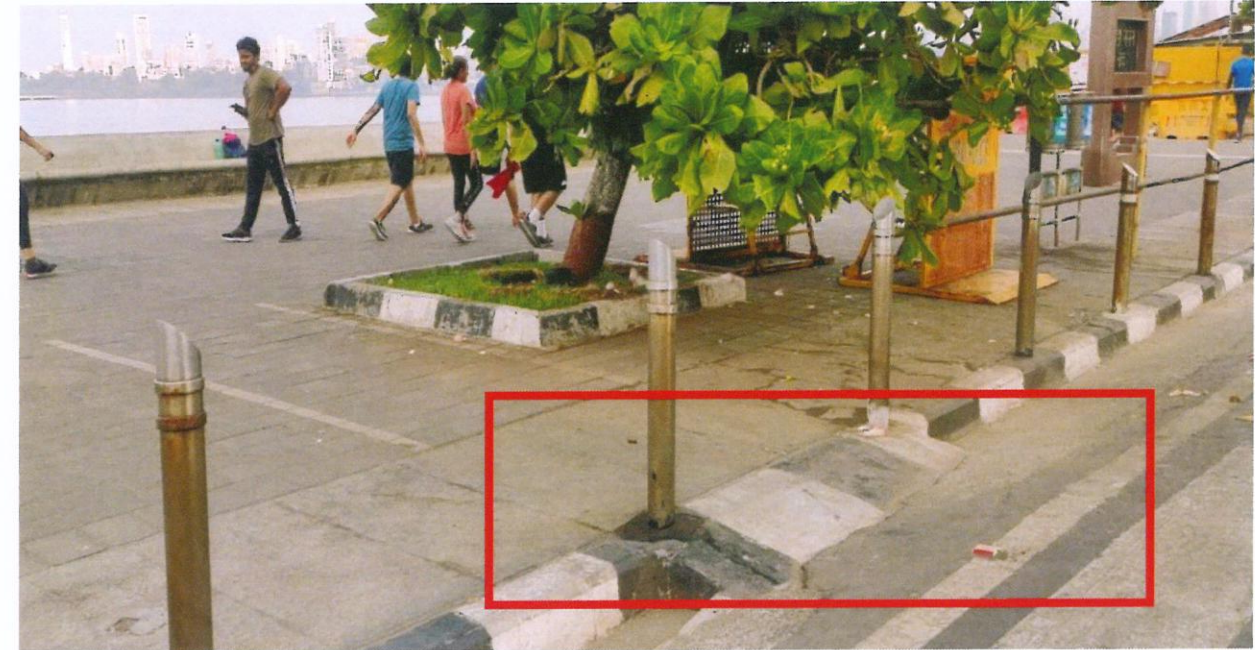
Ramps and access ways to and from the promenade

Ramped accesses to the promenade are of an inefficient gradient.
There is no indication or signage provided to identify these ramped access point to and from the promenade.

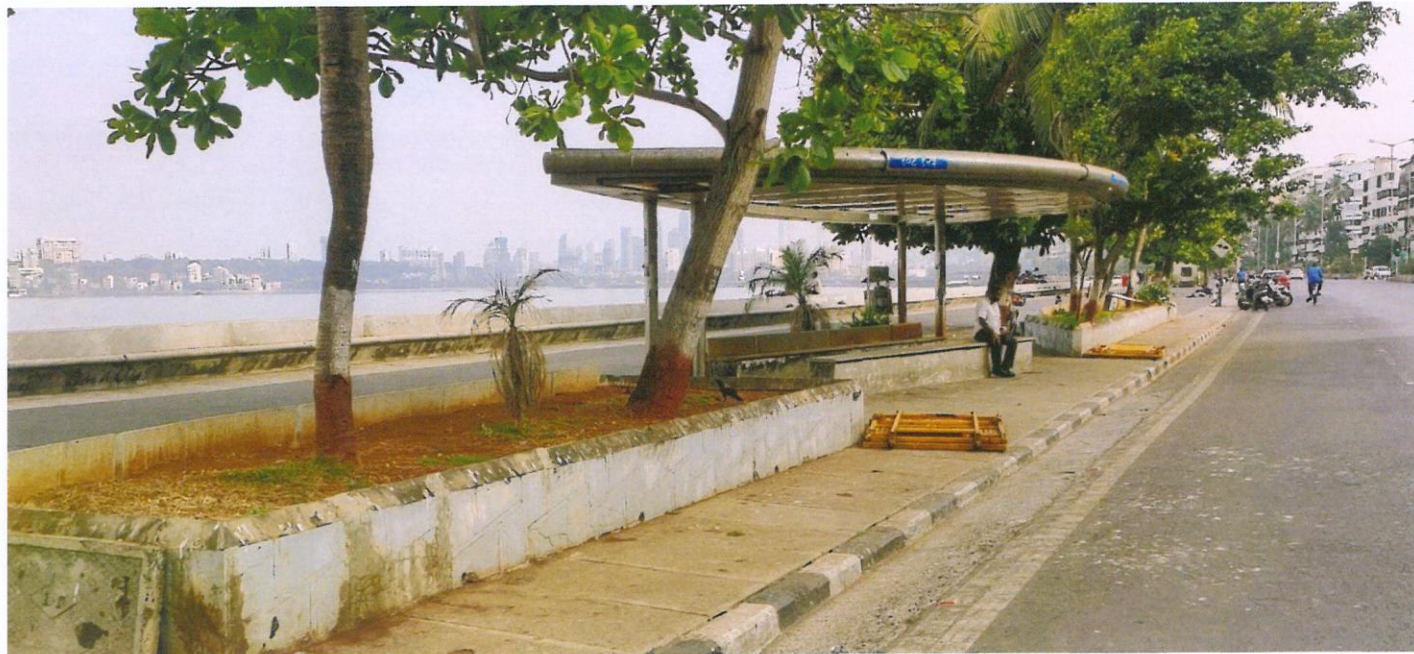
2. Bus stops

The road is at a lower level than the promenade and there is no ramped access to the road level from the bus stop for person to alight the bus. There is no dedicated wheelchair parking indicated at the bus stop.

The bus numbers are not readable and are not placed at an accessible height.

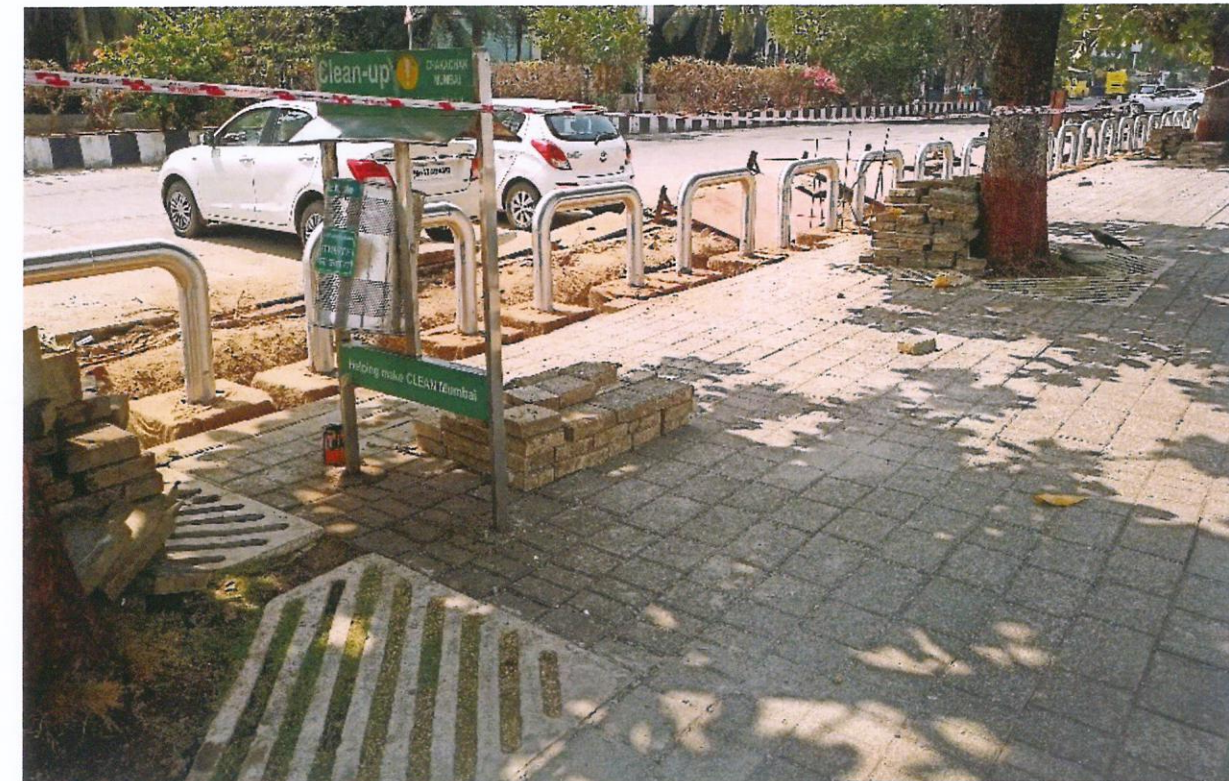
3. Newly installed bollards

The newly installed bollards are 700 to 800 mm apart making them inaccessible for a wheelchair user. Minimum width required for a wheelchair to access a space is 900mm.

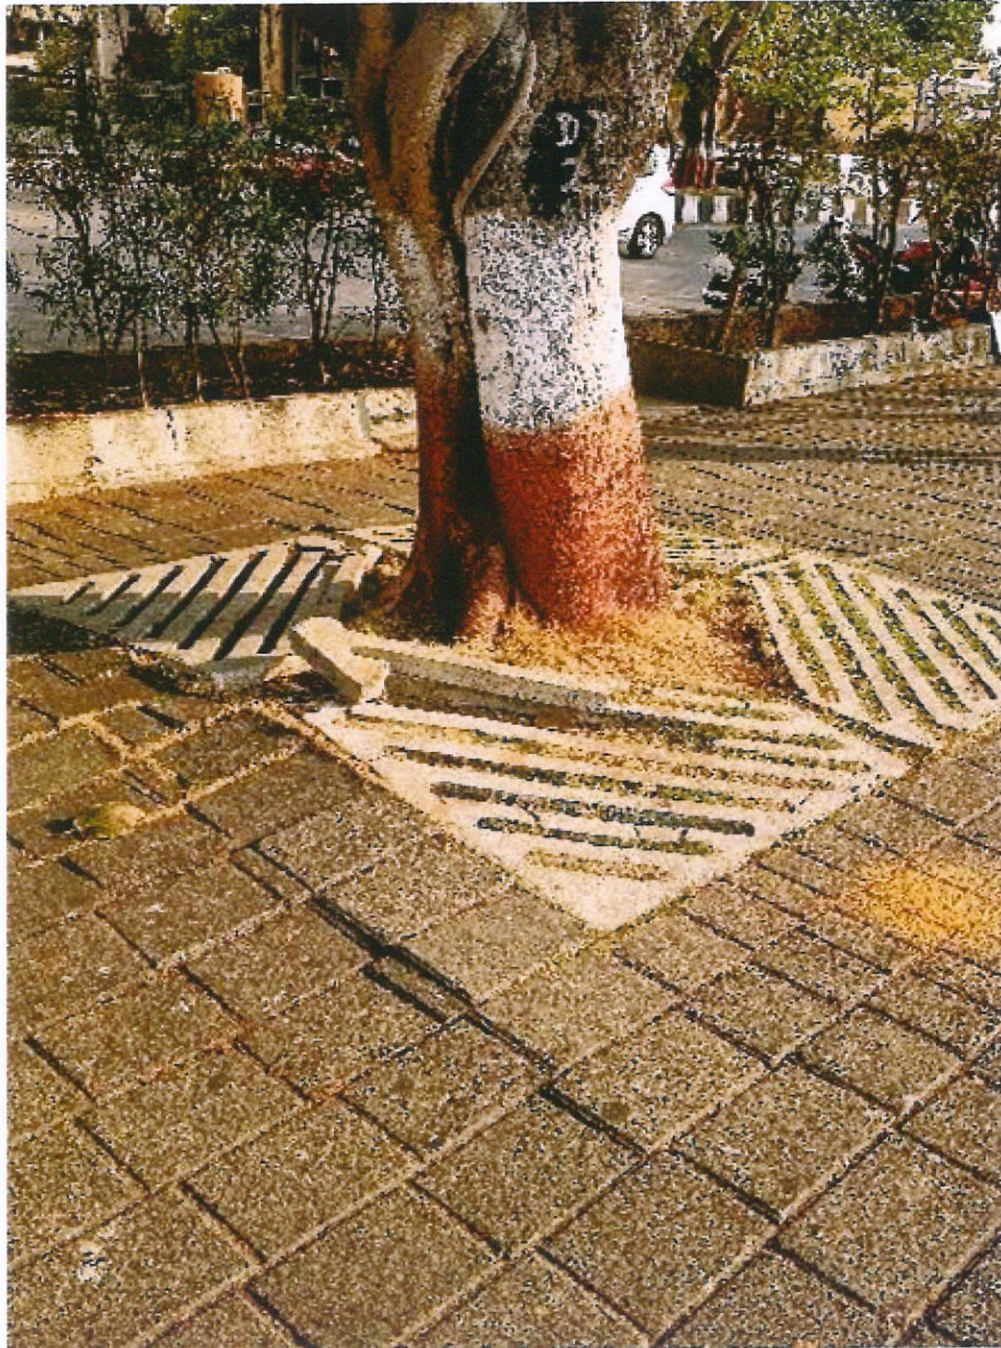
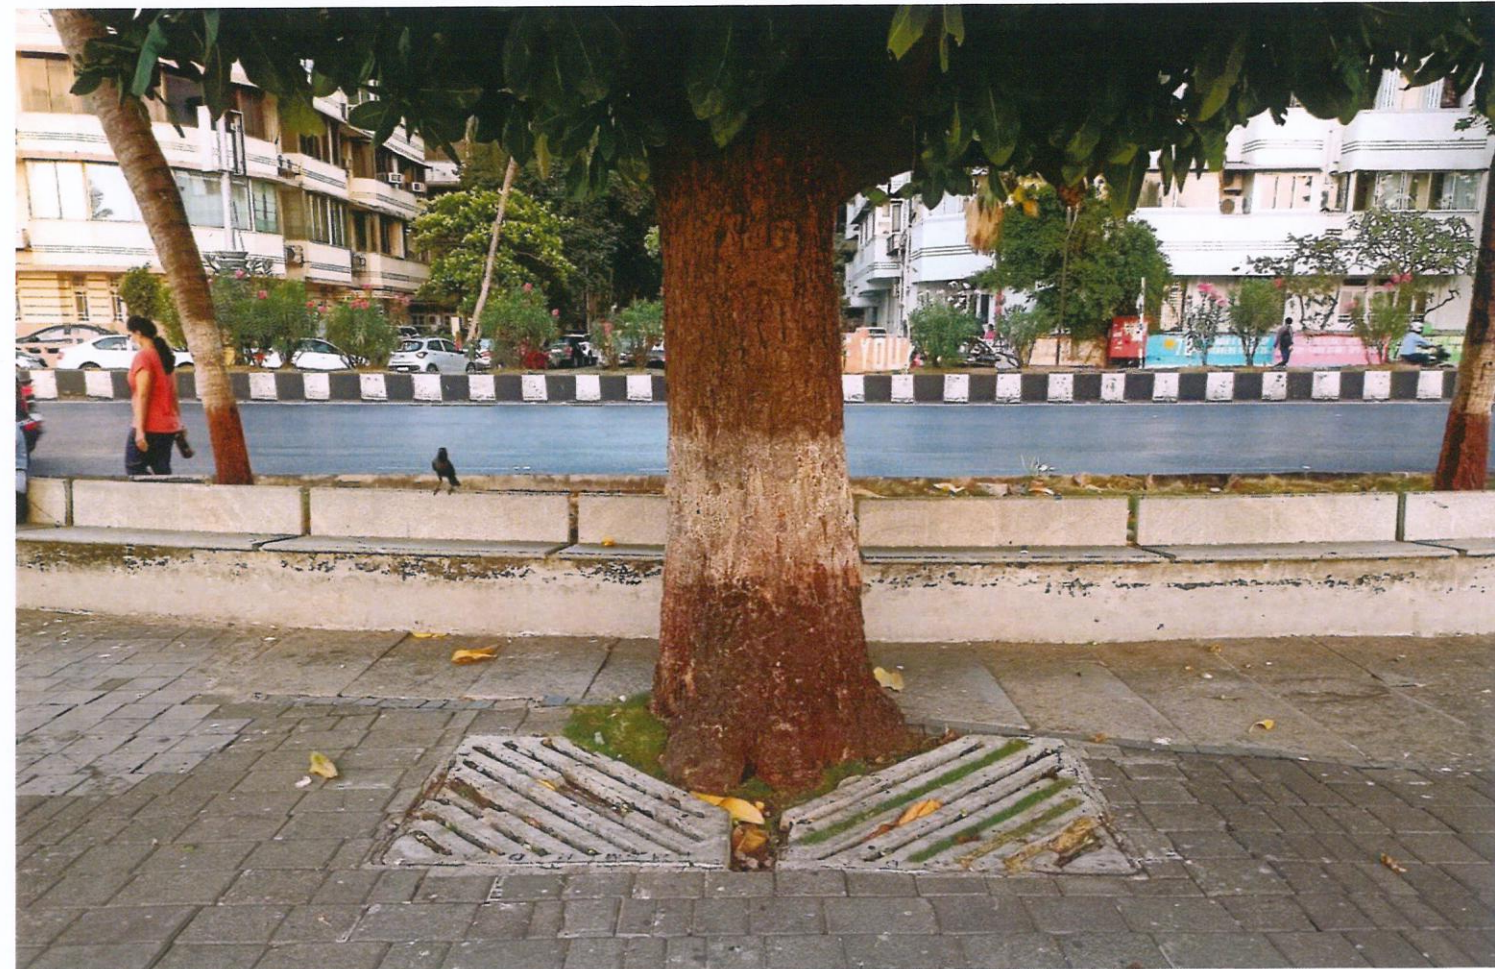
4. Tree gratings

The growing roots of the trees resulting in broken grating and immediate paving. This creates an uneven surface making the area around the trees inaccessible for persons with disabilities.

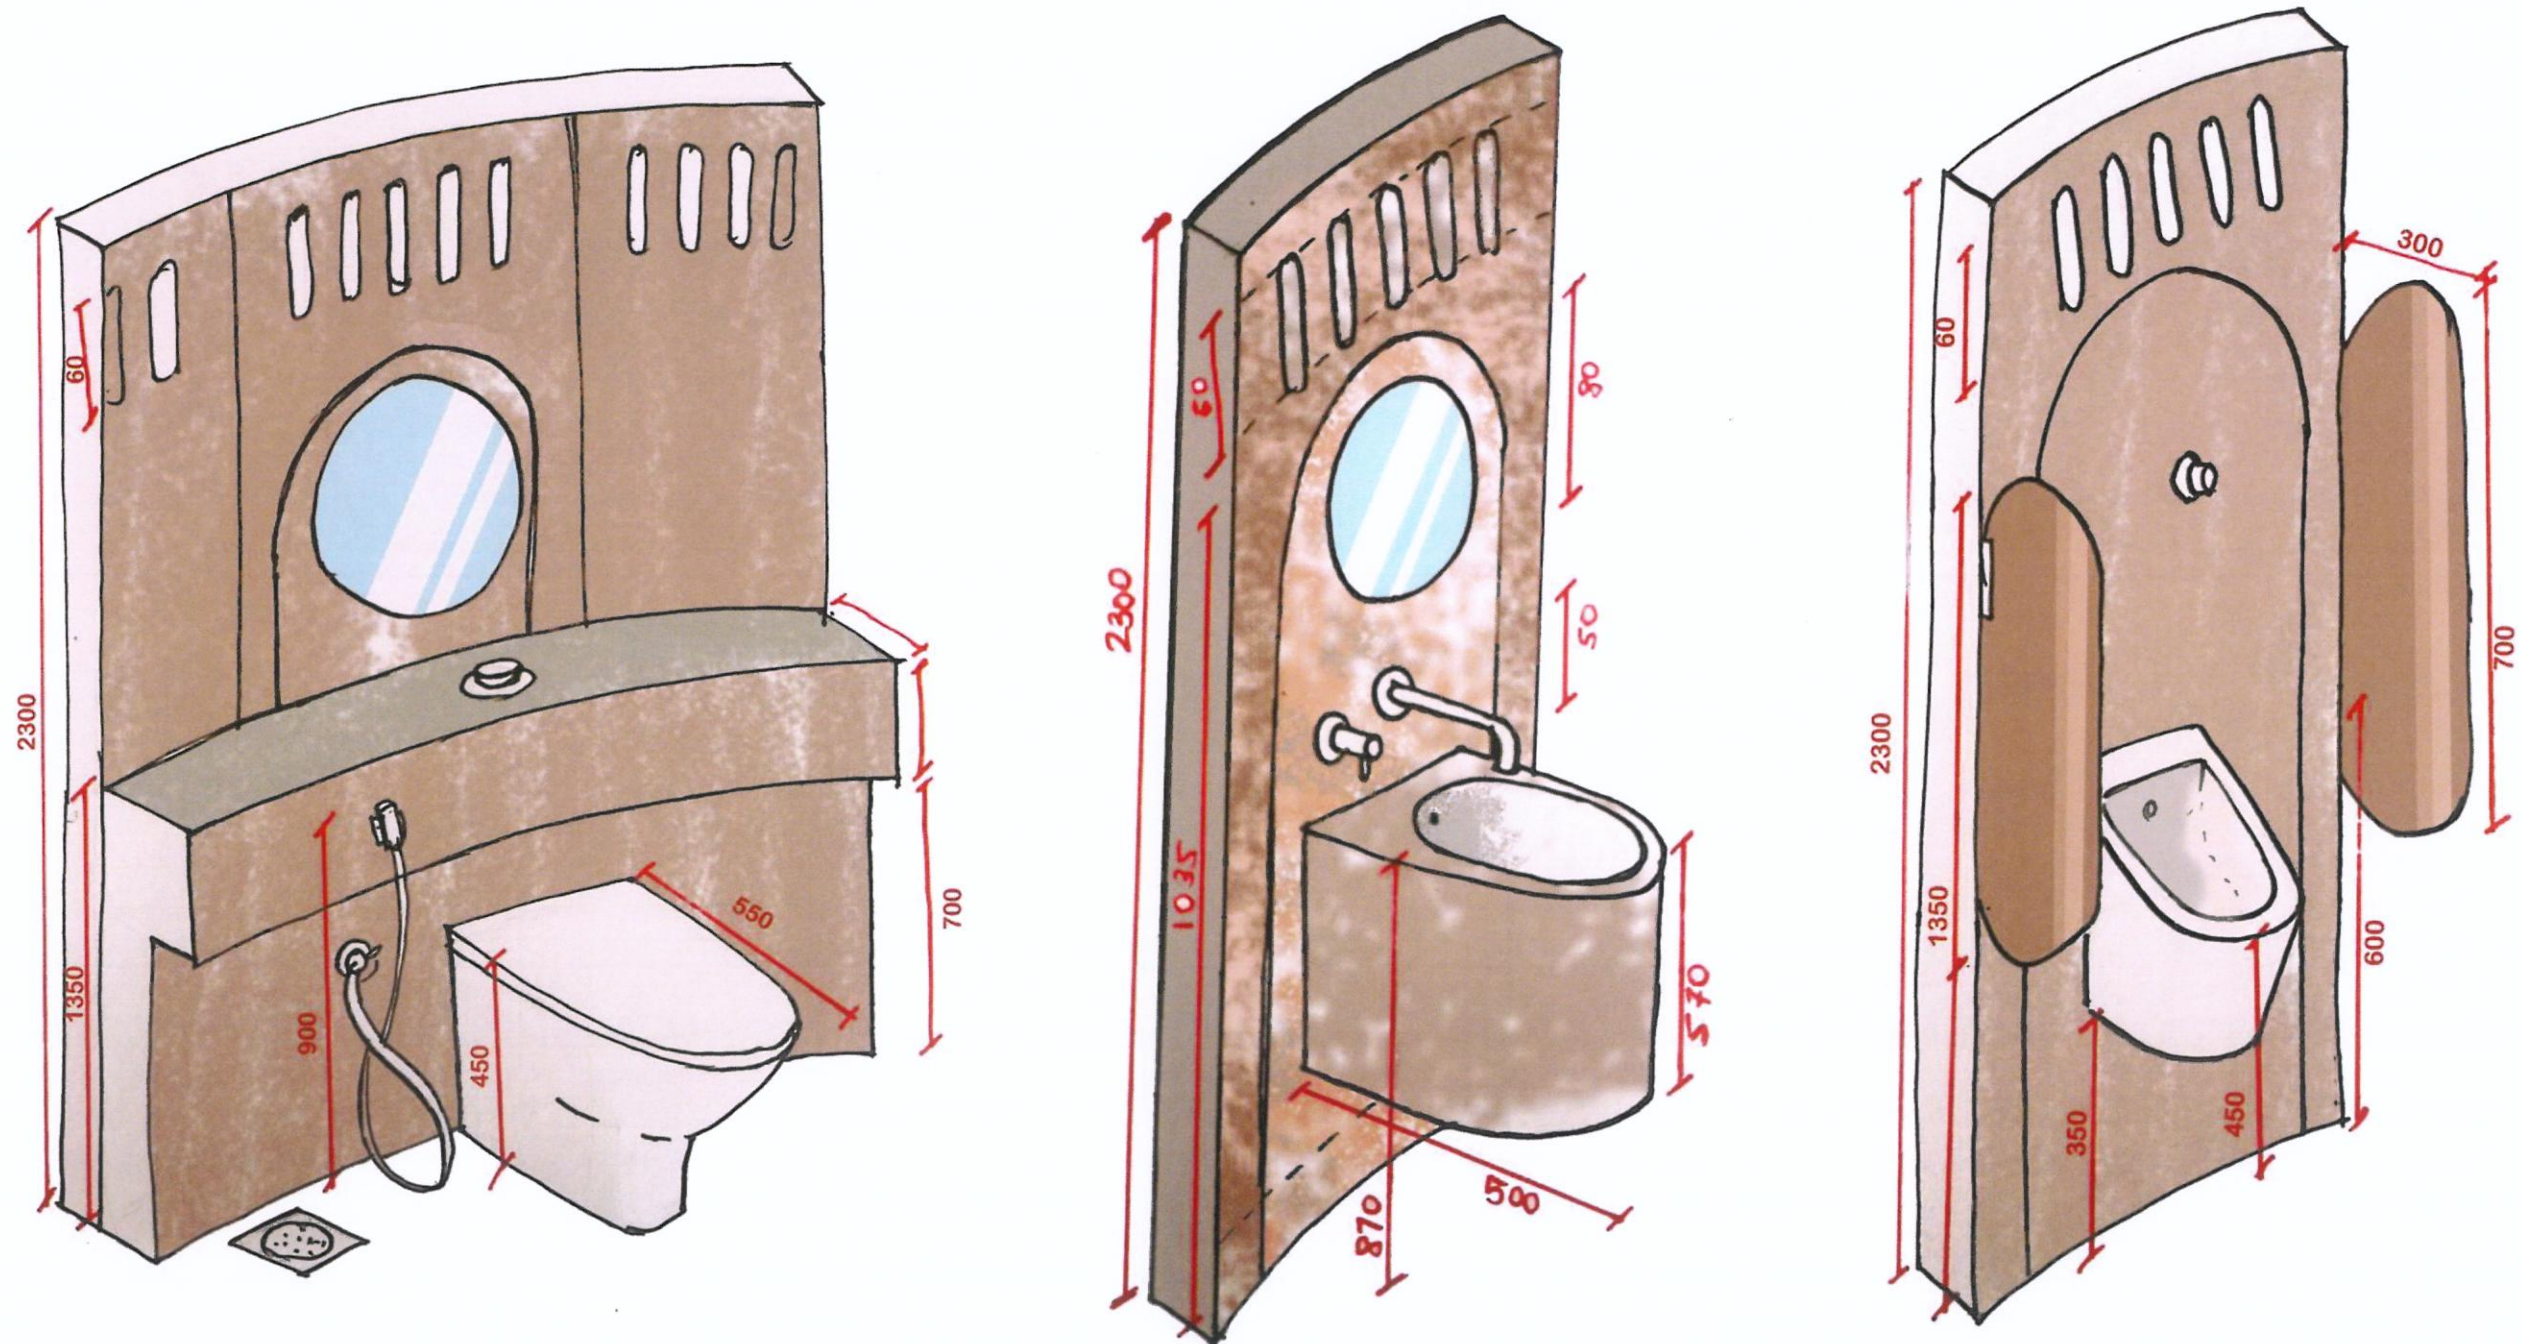
Disability	No.	Question	Answers			Notes	Photograph no	Recommendation as per MoUD guidelines
Marine Drive		Interval/Serial No.	0-100					
			Yes	No	NA			
TOILET								
L/VI		Are there accessible toilets for Persons with Disabilities?					J1.1, J1.6	8. Access to Toilet Facility
		Are the toilets easily identifiable?						
L/VI		Is there sufficient space of 2m x 2.2m inside the toilets to manoeuvre a wheelchair?				The dimension of toilet cubicle is 1300mm x 1550mm which is less than required.	J1.4, J2.3, J2.4	8. Access to Toilet Facility 8.2. Unisex Accessible Toilet
L/VI		Are water closet (WC) and bidets mounted at a height between 450mm – 480mm?						
L/VI		Is the space between the WC and the closest adjacent wall, fitted with a grab bar is between 450 mm – 500mm?				There are no grab bars on any of the cubicles.	J1.4, J2.3, J2.4	8.7- Water Closet grab bars
		Is the accessible washbasin mounted at a height between 750mm – 850mm?				The washbasin is at a height of 870mm.	J1.2, J2.2	11.1- Sidewalks/ footpaths

L/VI		Is the lower edge of the mirror positioned at a height not exceeding 1m?				No, lower edge of mirror is at 1300mm.	J1.2, J2.2	8.8- Washroom Accessories
L/VI		Are the accessible showers provided with a folding seat?				No shower area provided.		
L/VI		Are the grab bars installed near WC and showers at a height between 750 – 850 mm?				No grab bars provided.	J1.4, J2.3, J2.4	8.7- Water Closet grab bars
L/VI		Do grab bars have a diameter of 38 mm?

Disability	No.	Question	Answers			Notes	Photograph no	Recommendation as per MoUD guidelines
Marine Drive		Interval/Serial No.	0-100					
			Yes	No	NA			
		Are faucets easy to grip and operate with one hand?						8.8- Washroom Accessories
		Is the tap lever-type?				Operational lever is not connected to the faucet.		
L/VI		Is the toilet equipped with an emergency alarm system?				No alarm provided.		
L/VI		Can doors be locked from inside and releasable form outside under emergency situations?						8.8- Washroom Accessories
L/VI		Are flushing arrangements, dispensers and toilet paper mounted between 300mm and 800mm?				No toilet paper holder provided.		
L/VI		Are flushing equipments easy to operate?				Flushing nib is push type.	J1.4, J2.3, J2.4	
L/VI		Is the floor material skid proof, well drained and waterproof?				The washroom is not well drained, water logging areas present.		
L/VI		Is there adequate colour and tonal contrast between the fixtures, walls and the flooring?				No contrast between the walls and flooring.	J1.5, J1.2, J2.2

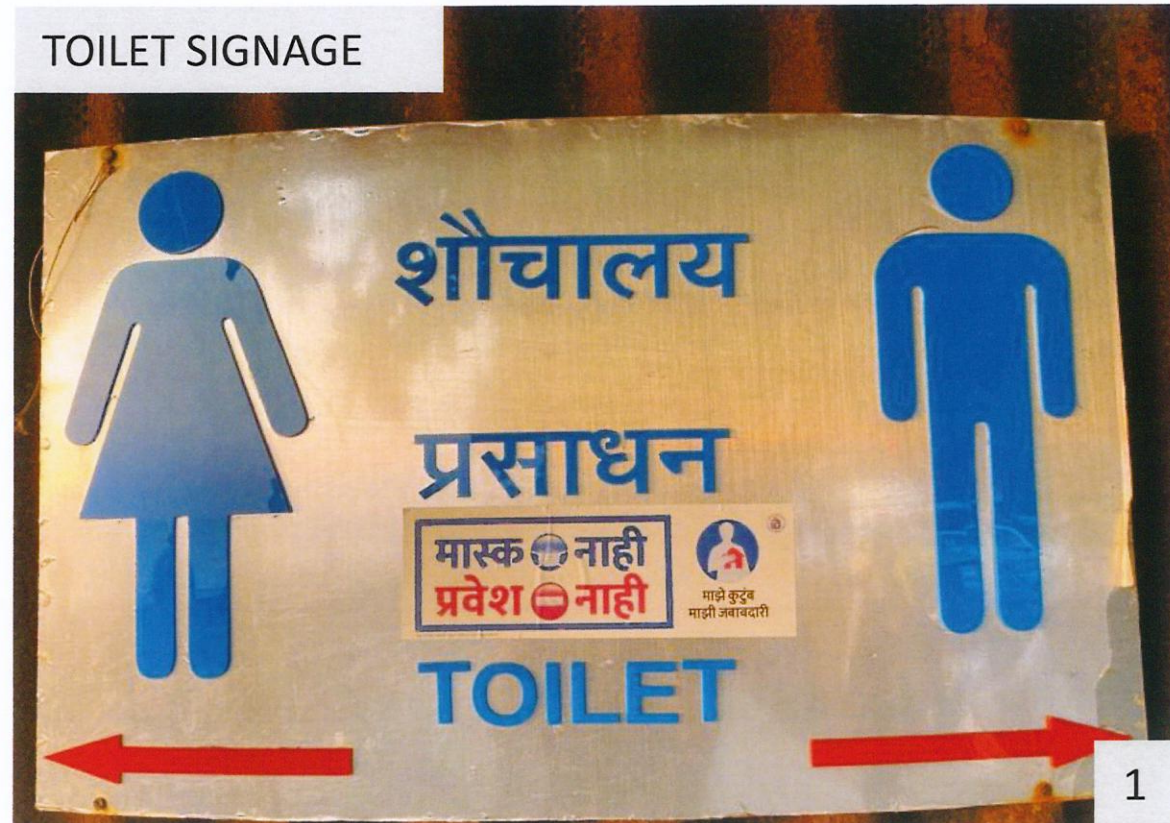
TOILET ENTRANCE SIGNAGE

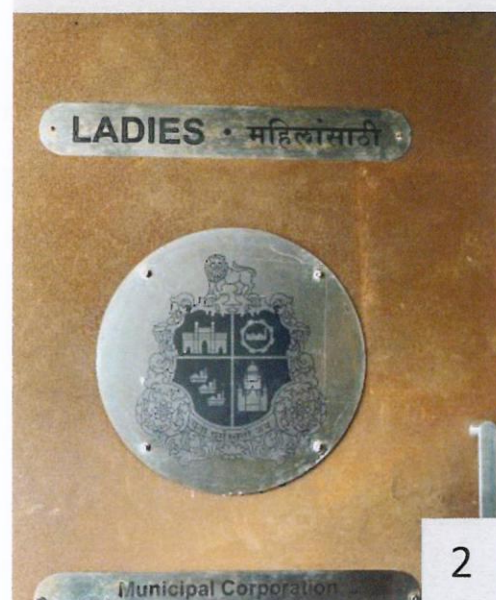
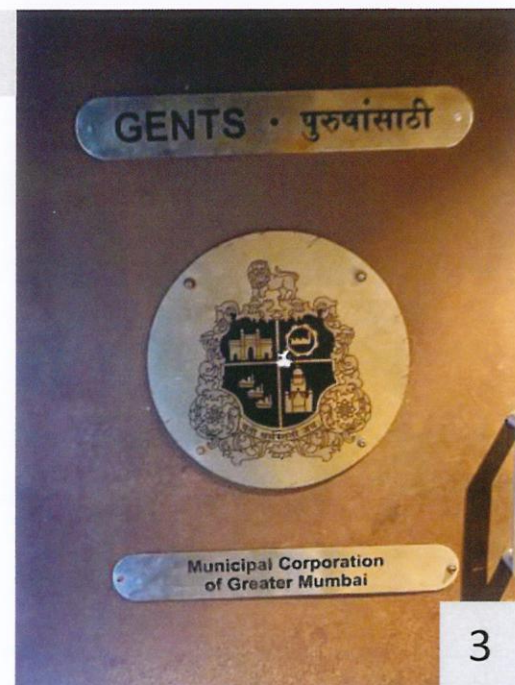
TOILET PROJECT DETAILS

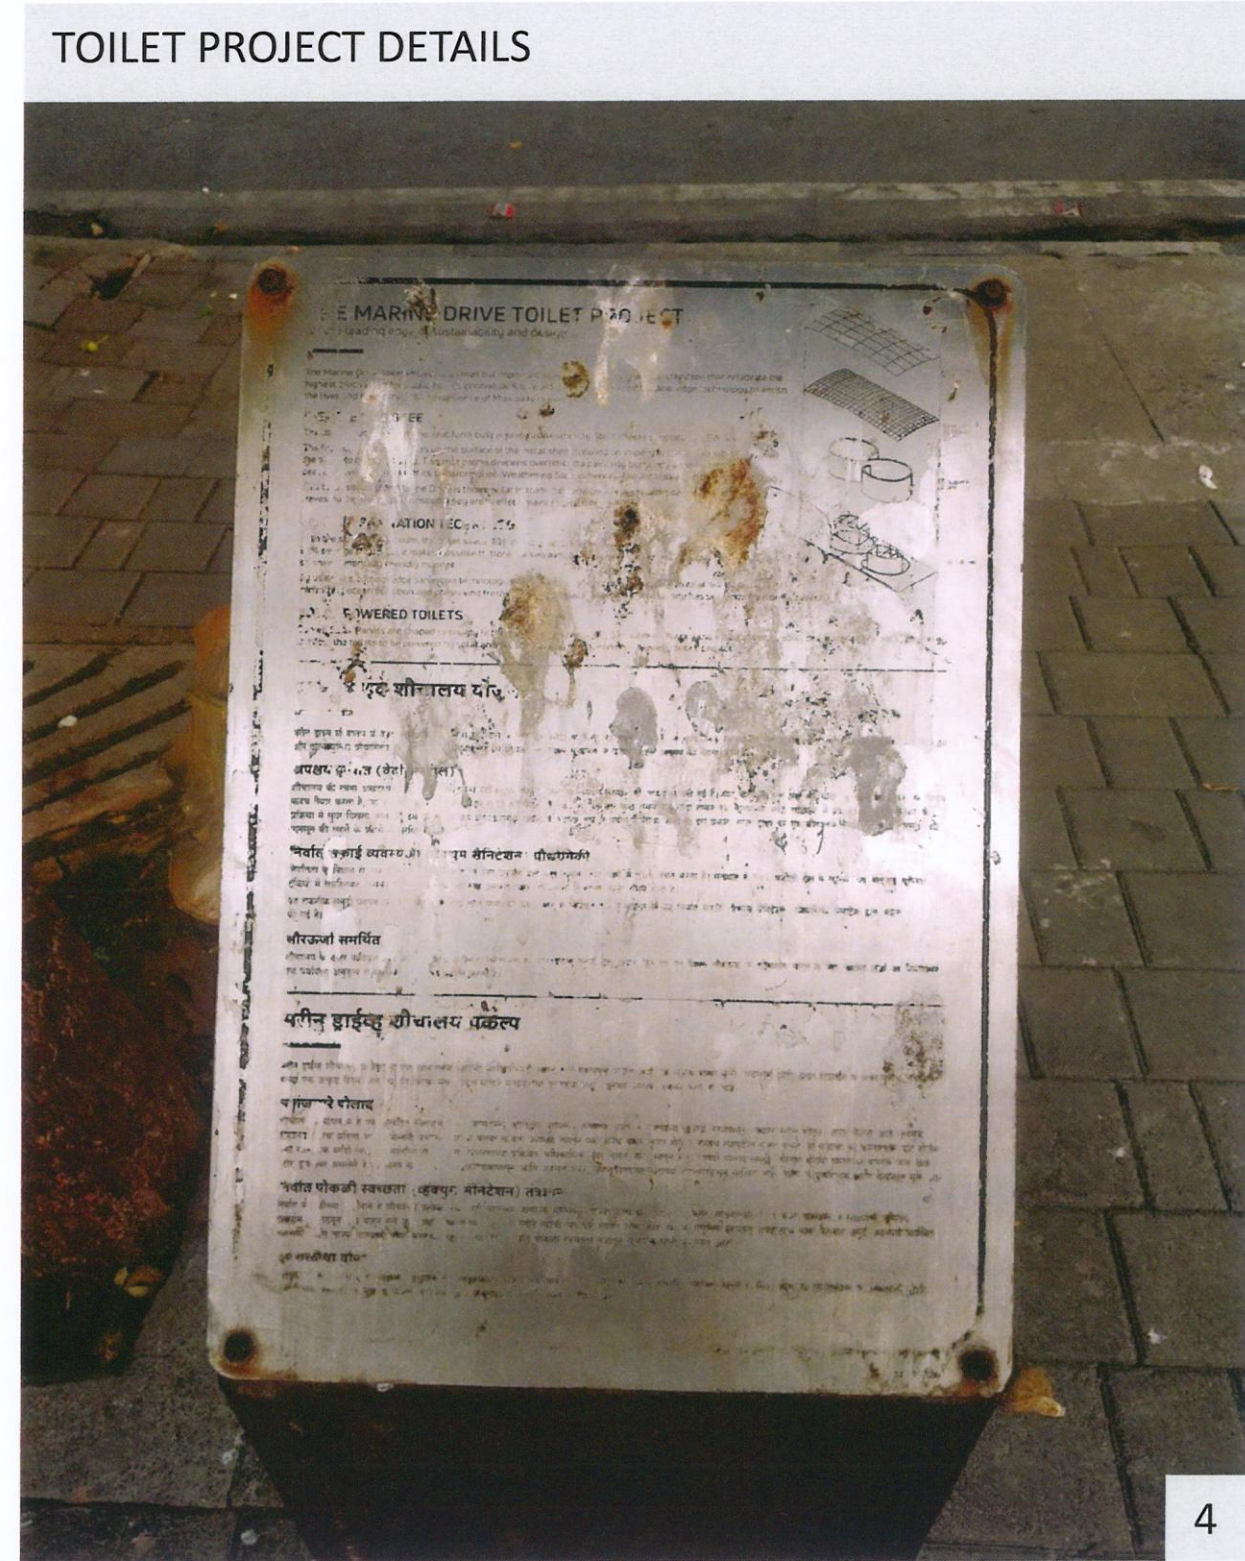
DESTINATION SIGNAGE TYPE 1

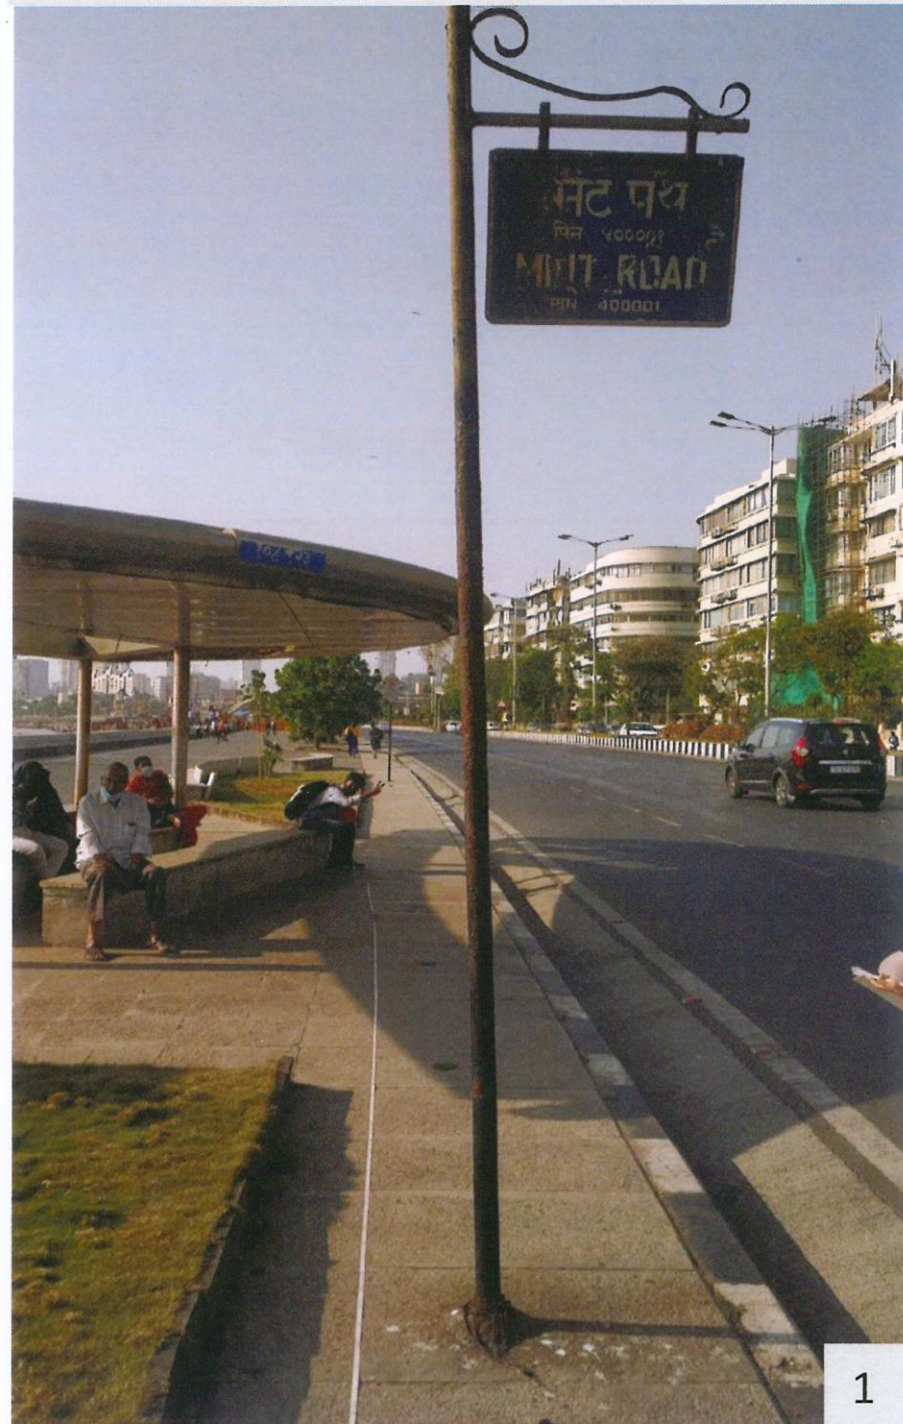
DESTINATION SIGNAGE TYPE 2

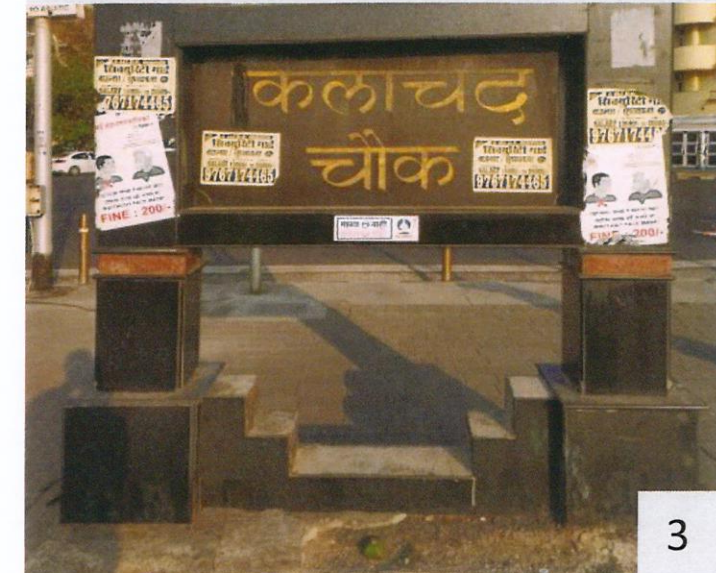
DESTINATION SIGNAGE TYPE 3

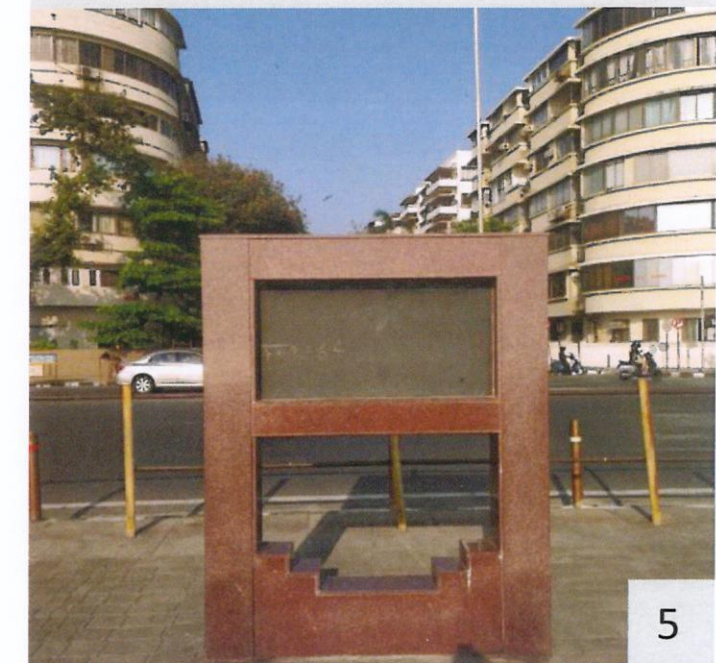
DESTINATION SIGNAGE TYPE 3

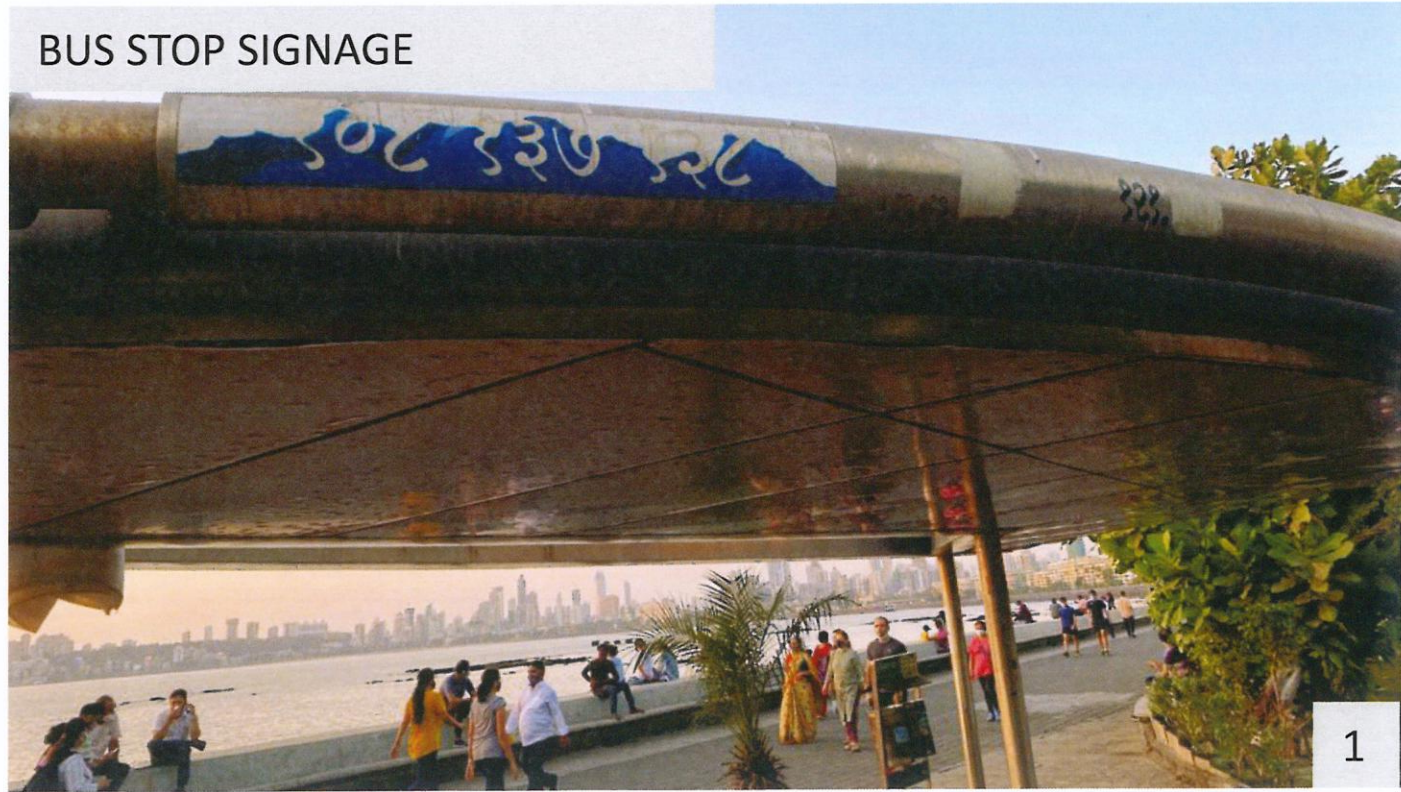
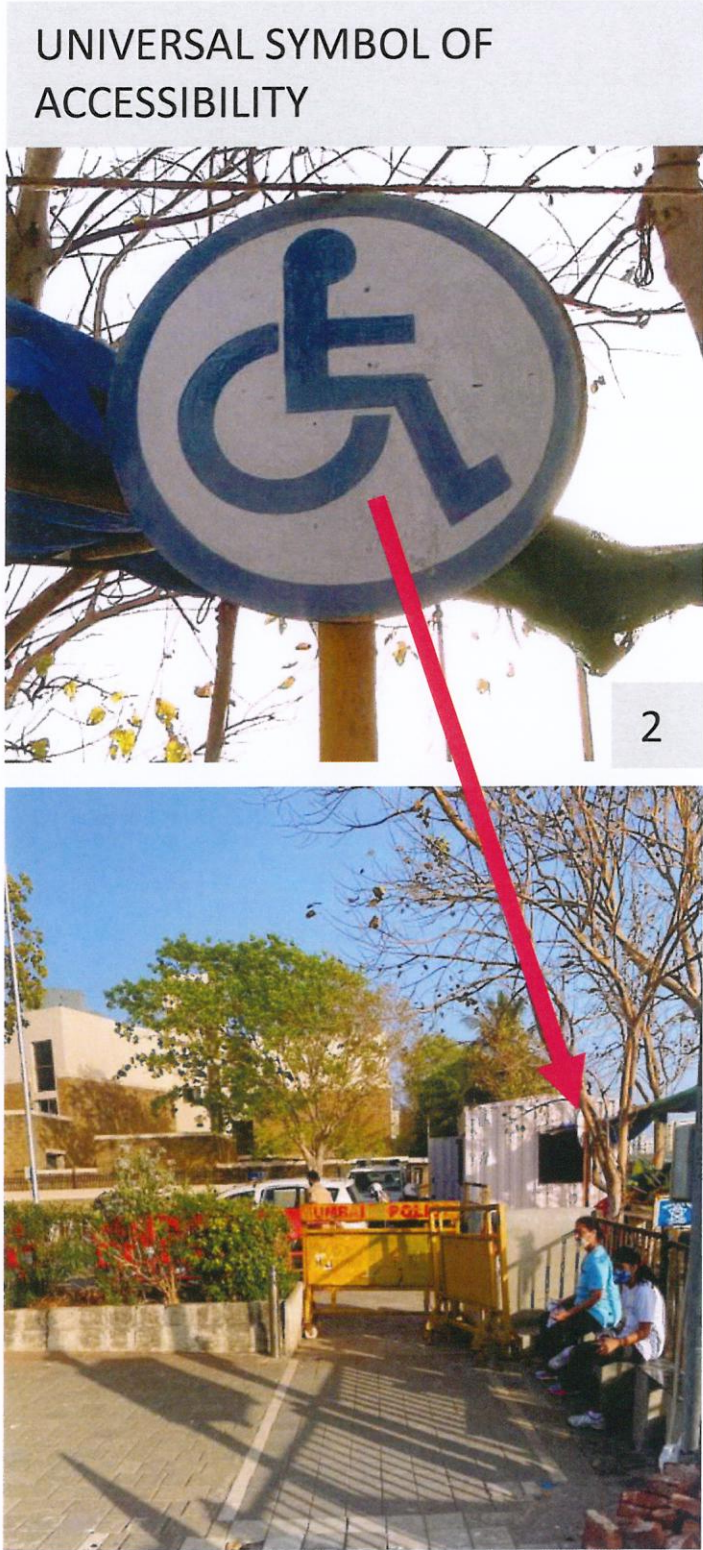
Disability	No.	Question	Answers												Notes	Photograph no	Recommendation as per MoUD guidelines
		Interval/Serial No.	Parking sign			Parking Instructions			Toilet			Directional					
			Yes	No	NA	Yes	No	NA	Yes	No	NA	Yes	No	NA			
SIGNAGES																	
L/VI		Are accessible spaces identified by the international symbol of accessibility?													There are no dedicated accessible spaces.	K1.1, K1.2, K1.3, K2.2, K2.2, K2.3	6.1. Signage Provisions 6.2. Types of Signage
		Are there directional signs indicating the location of accessible facilities?													There are no accessible facilities provided except for the ramps at the entryways, but even those are not provided with an directional signage and destination signage.		
L/VI		Are maps, information panels and wall-mounted signs placed at a height between 900mm and 1800mm?													Signs at a height of 1900 to 2000mm.	K1.1, K1.2, K1.3, K2.2	6.3. Location of Signage

L/VI		Are signs clear, simple and easy to read?													Font size is not readable from a distance.	K1.1, K1.2, K1.3, K2.2	
		Is the colour of signs clearly distinguishable?															
L/VI		Is the surface of the sign processed so as to prevent glare?													Parking sign, instruction and toilet are in metal.	K1.1, K1.2, K1.3, K2.2	
L/VI		Is the sign supplement by a text in embossed letters or in Braille available next to information signs?														K1.1, K1.2, K1.3, K2.2	
L/VI		Is the lettering size proportional to the reading distance?														K1.1, K1.2, K1.3	6.4. Universal Signage
